# Arboricultural Report

Tree Survey,  
Arboricultural Impact Assessment &  
Arboricultural Method Statement

**Forest Road  
Swords  
Co. Dublin**

**June 2025**

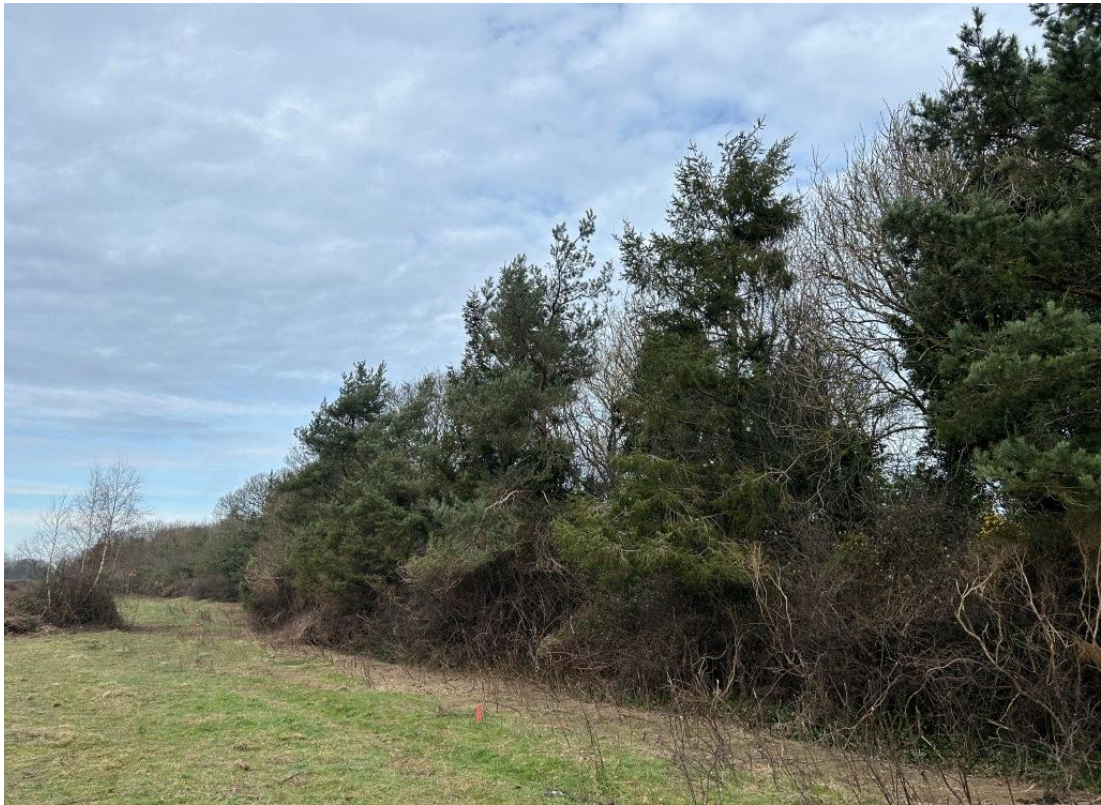
**Image 1:** View of the northern boundary tree and hedgerow (G31). The pine trees have been planted on the site side of the fence, while the original townland boundary is located behind.

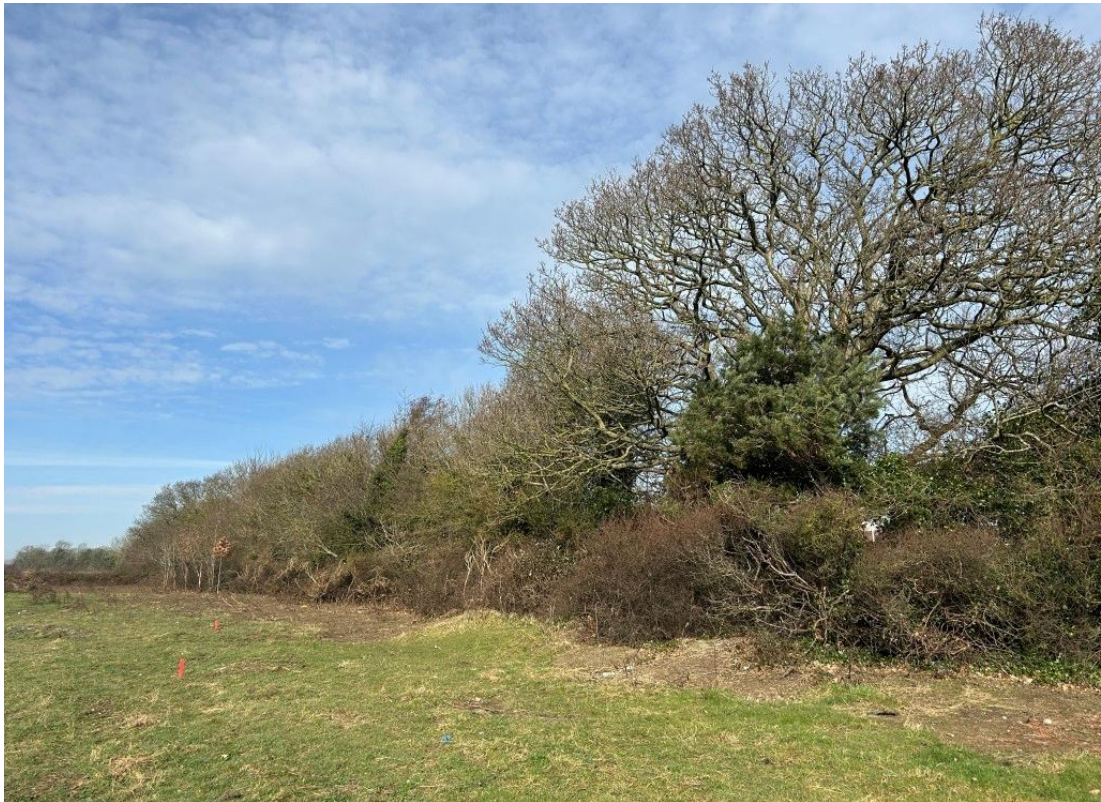
**Image 2:** View of the A Category oak T19 and the tree and hedge group G31 located along the northern townland boundary.

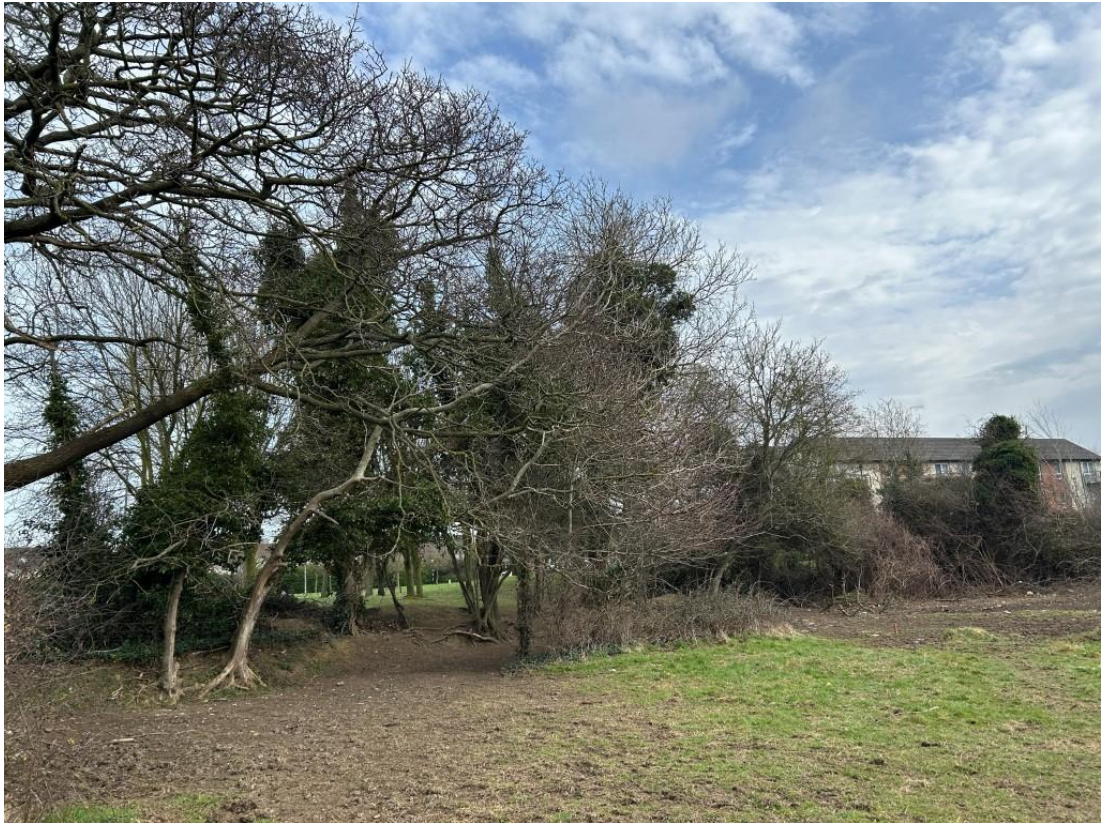
**Image 3:** View of trees located at the corner of the site that connects to Ridgewood Green.

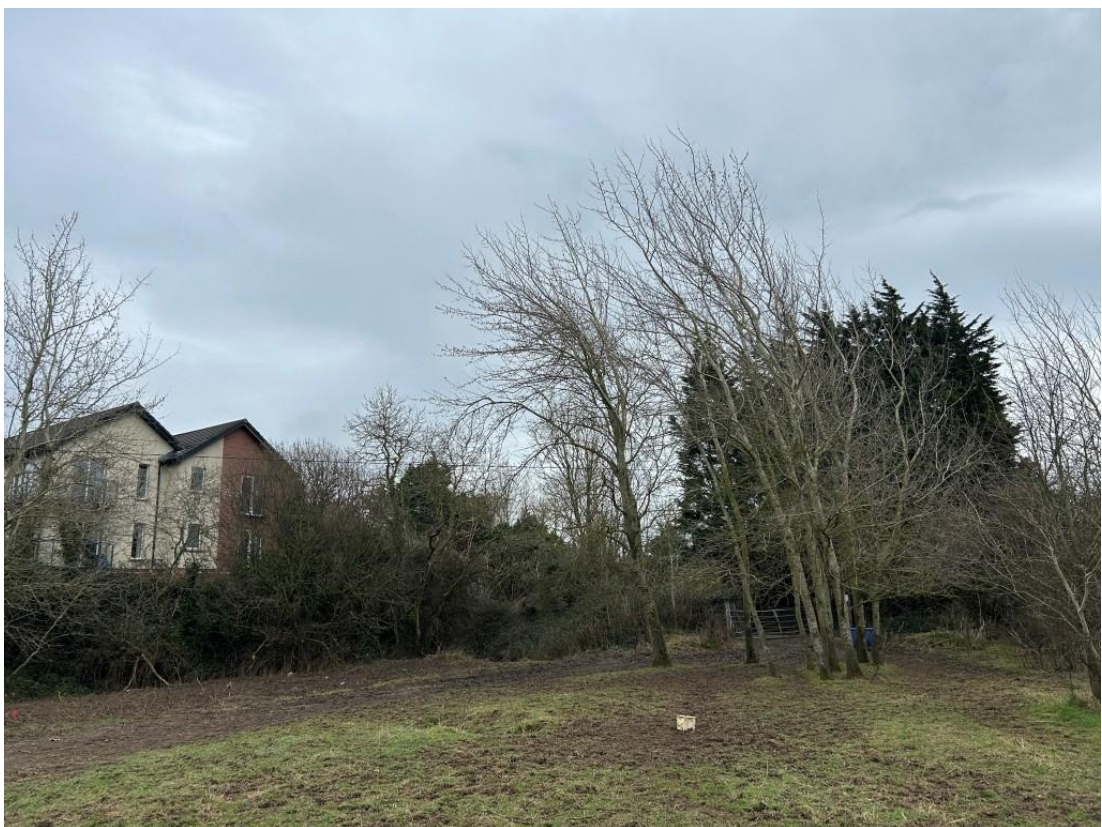
**Image 4:** View of the northeastern boundary tree and hedge group (G33) located behind Ridgewood Grove and the group of grey poplars (T73 to T82) at the existing entrance.

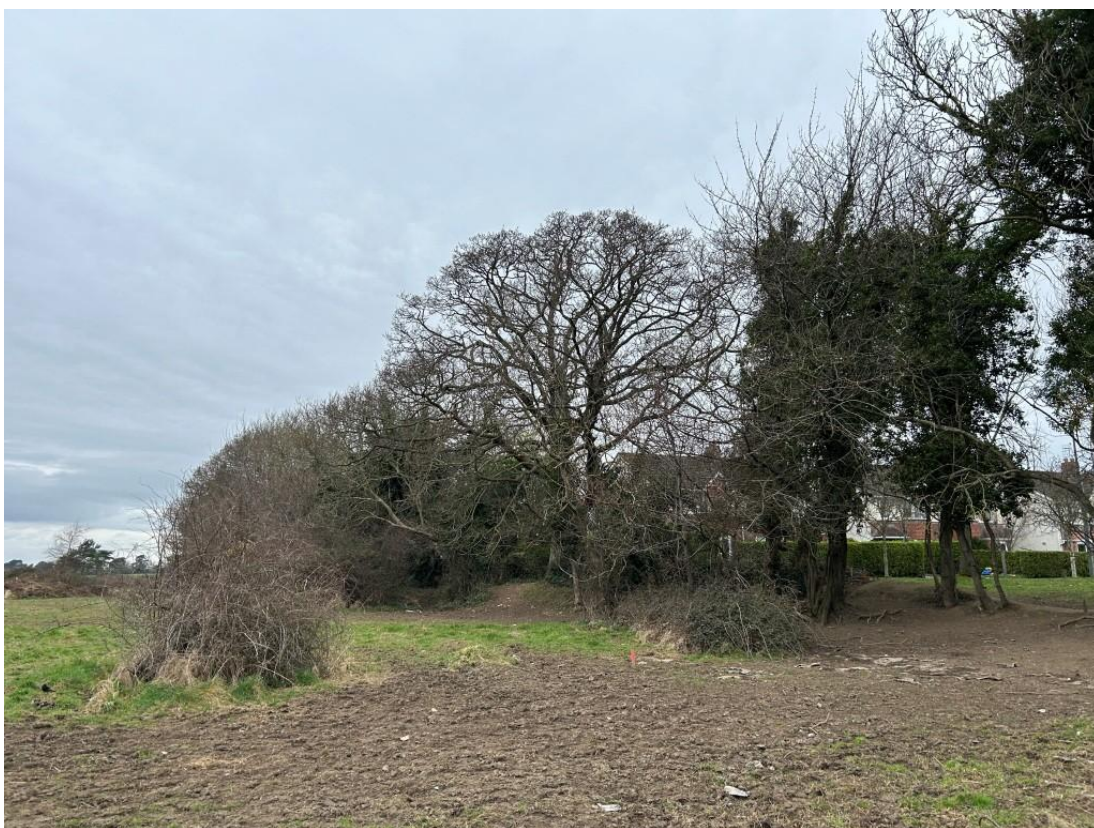
**Image 5:** View of the A Category Oak T30 and surrounding trees.

- 6.10 **Construction operation** – The main built element of the proposal has been carefully designed to minimise the impact on the retained trees and hedgerows. A minor incursion within the RPA of the A Category oak T30 is required to facilitate the construction of a new road and car parking bay. This incursion is at the outer extent of the tree's rooting area and accounts for 3% of its overall RPA. This is considered to be minimal and will have an insignificant impact on the overall health and condition of the tree.

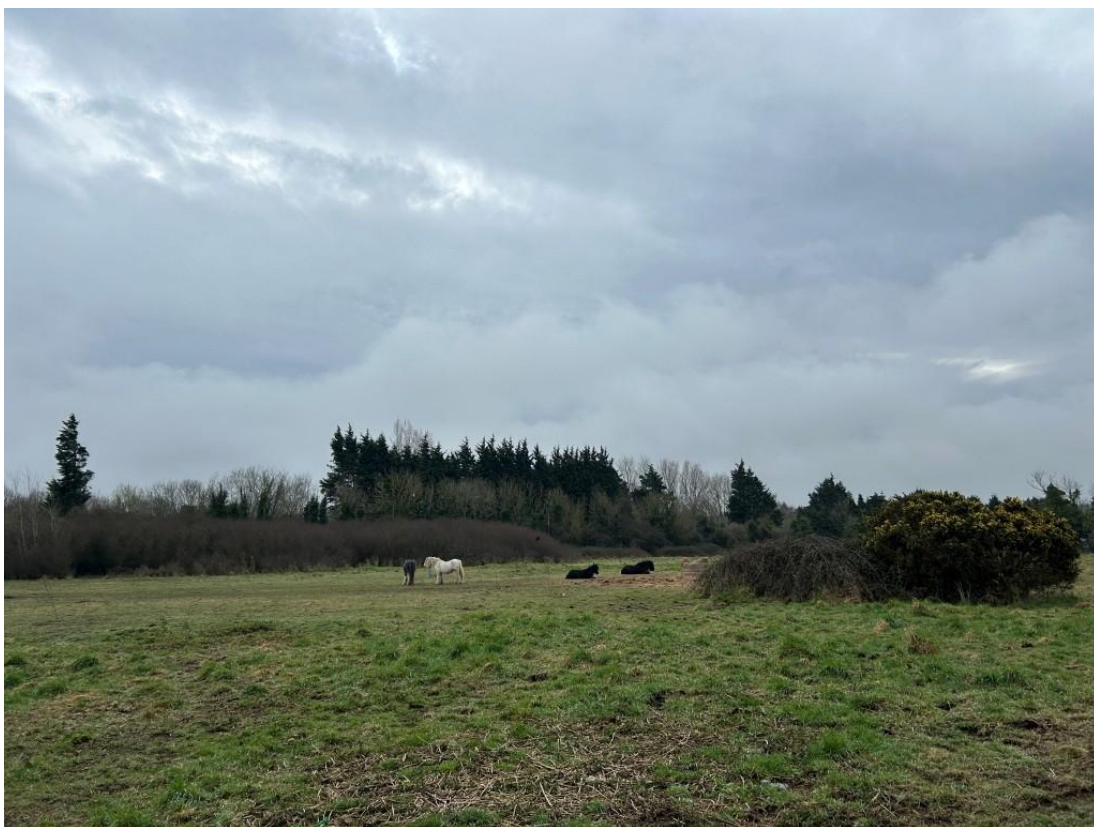
**Image 6:** View of the eastern boundary located adjacent to Forest Road. Photo shows the dense blackthorn and blamble group S1.
