5.0 BIODIVERSITY

Faith Wilson Ecological Consultant was commissioned by Birchwell Developments to prepare an Ecological Survey and Impact Assessment as part of a Large-scale Residential Development (LRD) Application for lands proposed for development on lands at Broomfield, Back Road, Malahide, Co. Dublin as shown on **Figure 5.1** below.

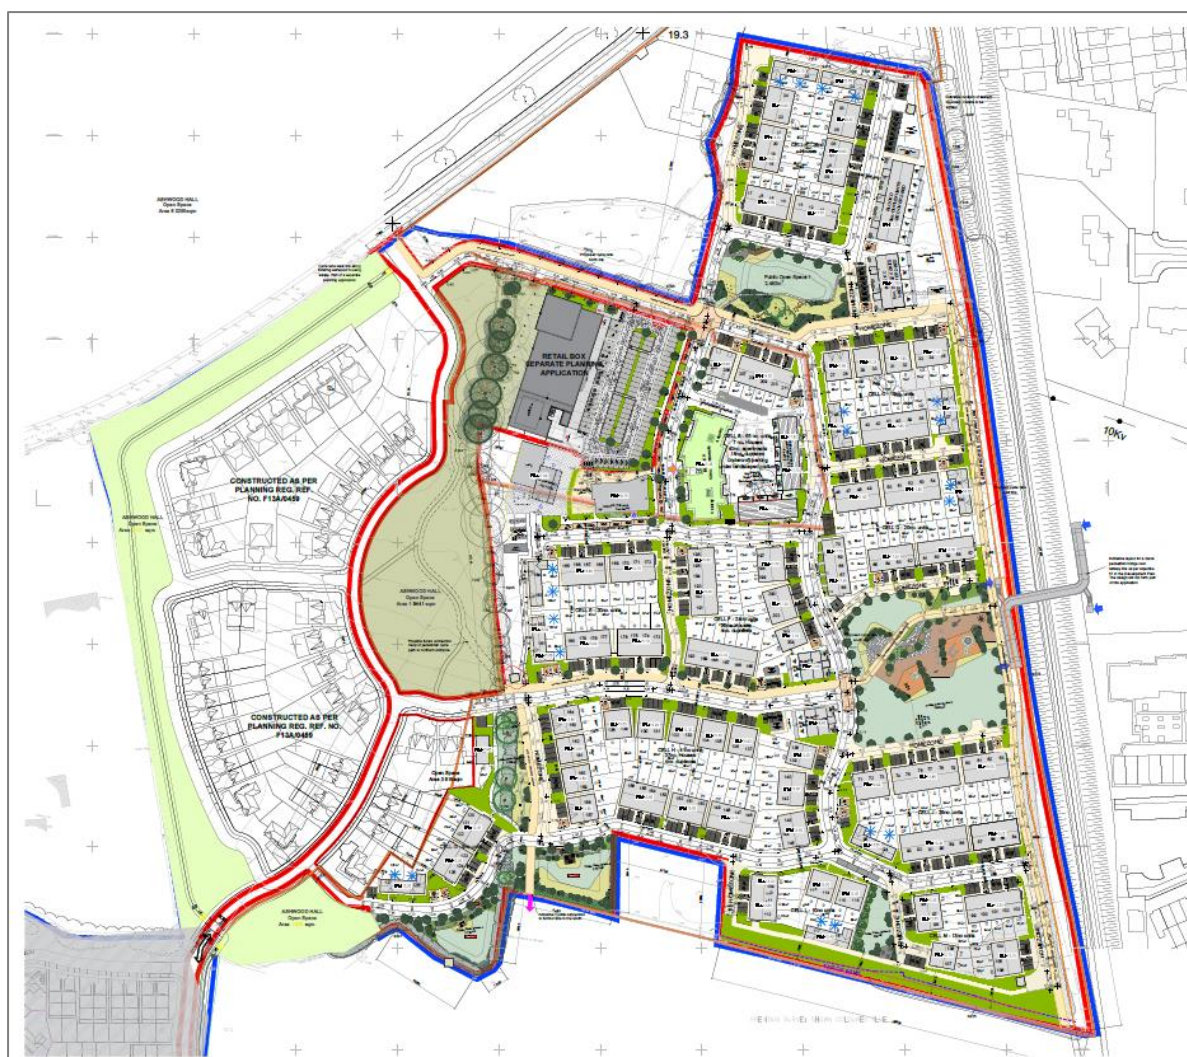
Figure 5.2 Proposed site layout for the Broomfield LRD, outlined in red at Broomfield, Malahide, Co. Dublin.

The proposed development subject to this Large-Scale Residential Development (LRD) application provides for the demolition of the former rugby clubhouse structure on site and the construction of 297 no. residential units comprising 211 no. houses (14 no. 2 beds, 156 no. 3 beds, 39 no. 4 beds, and 2 no. 5 beds), 46 no. duplex units (9 no. 1 beds, 14 no. 2 beds, and 23 no. 3 beds), 40 no. apartments (23 no. 1 beds, 14 no. 2 beds, and 3 no. 3 beds); 1 no. childcare facility; 1 no. café/restaurant; 1 no. retail unit; 1 no. yoga studio; and all associated site infrastructure and engineering works necessary to facilitate the development. Furthermore, the proposed development provides for a temporary pumping station situated to the southwest of the subject site, in addition to the proposed use of the existing vehicular access off Back Road (proposed vehicular access via Ashwood Hall), as shown on **Figure 5.1** and **5.2** above.

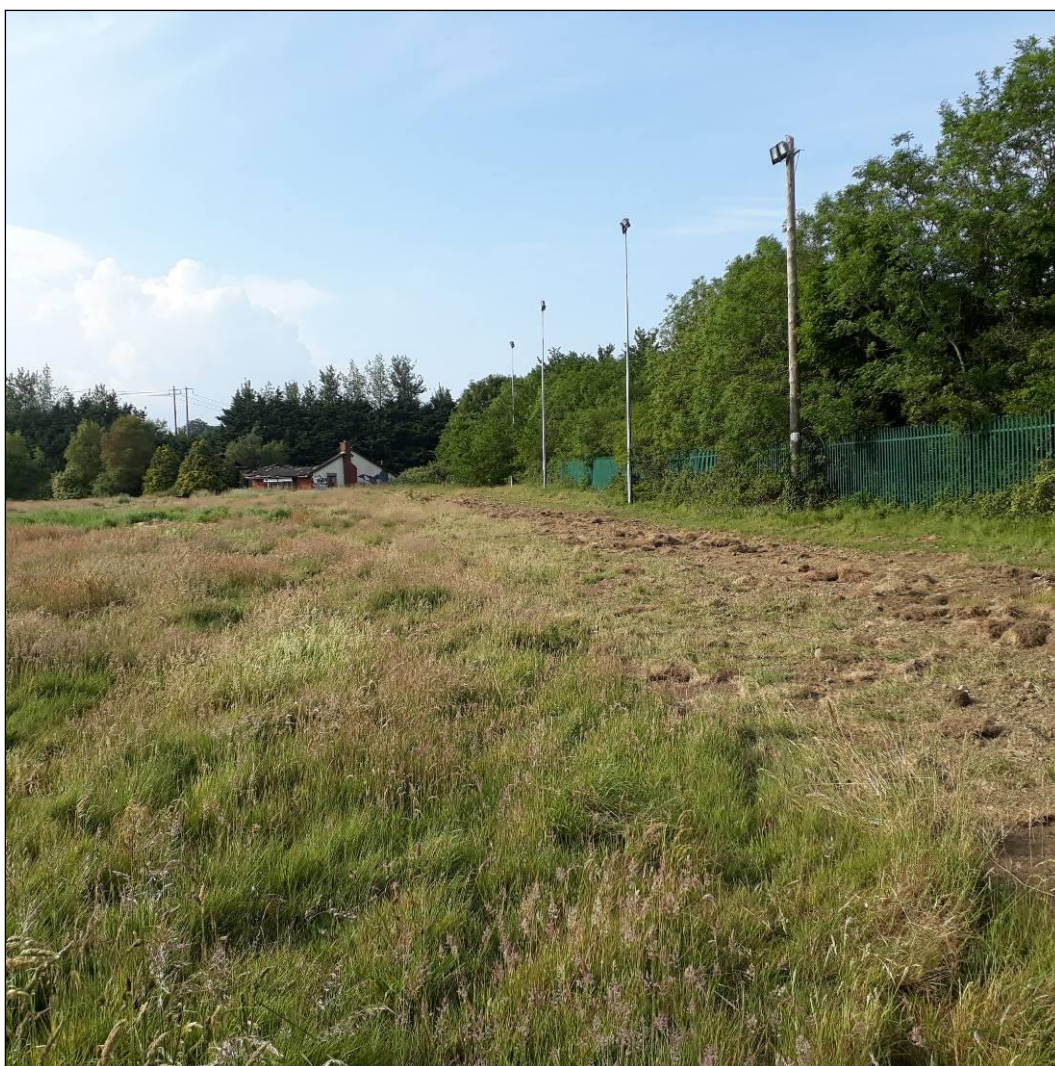
Plate 1. Eastern boundary of the rugby club lands adjoining the railway line.

The former Rugby Club lands are bounded to the east by the Dublin – Belfast railway line. Inside the palisade fence of the railway line and extending for the length of the site to the south is a bank of ash (*Fraxinus excelsior*) oak (*Quercus robur*), hawthorn (*Crataegus monogyna*), elm (*Ulmus procera*), and sycamore (*Acer pseudoplatanus*). These trees are located offsite and provide an important visual and acoustic screen between the site and the railway line. They are described as G227 in the tree survey report.

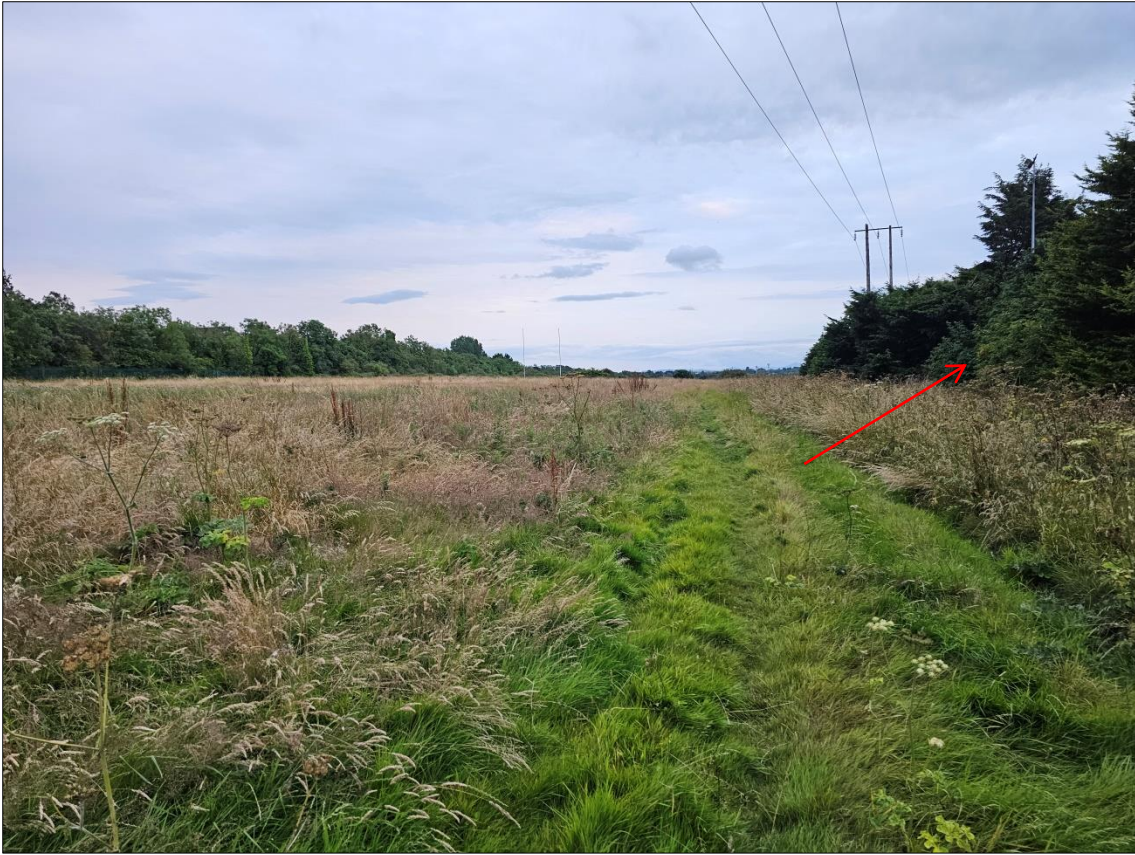
Plate 2. Looking south over the rugby club lands. Treeline G222/G223 is shown by the red arrow.

The grassland (GS2) on the former playing area is dominated by Yorkshire fog (*Holcus lanatus*), false oat-grass (*Arrhenatherum elatius*), cock's-foot grass (*Dactylis glomerata*), red fescue (*Festuca rubra*), with occasional dandelion (*Taraxacum* agg.), ribwort plantain (*Plantago lanceolata*), creeping buttercup (*Ranunculus repens*), meadow buttercup (*Ranunculus acris*) and germander speedwell (*Veronica chamaedrys*). This is becoming colonised by willows (*Salix cinerea*).

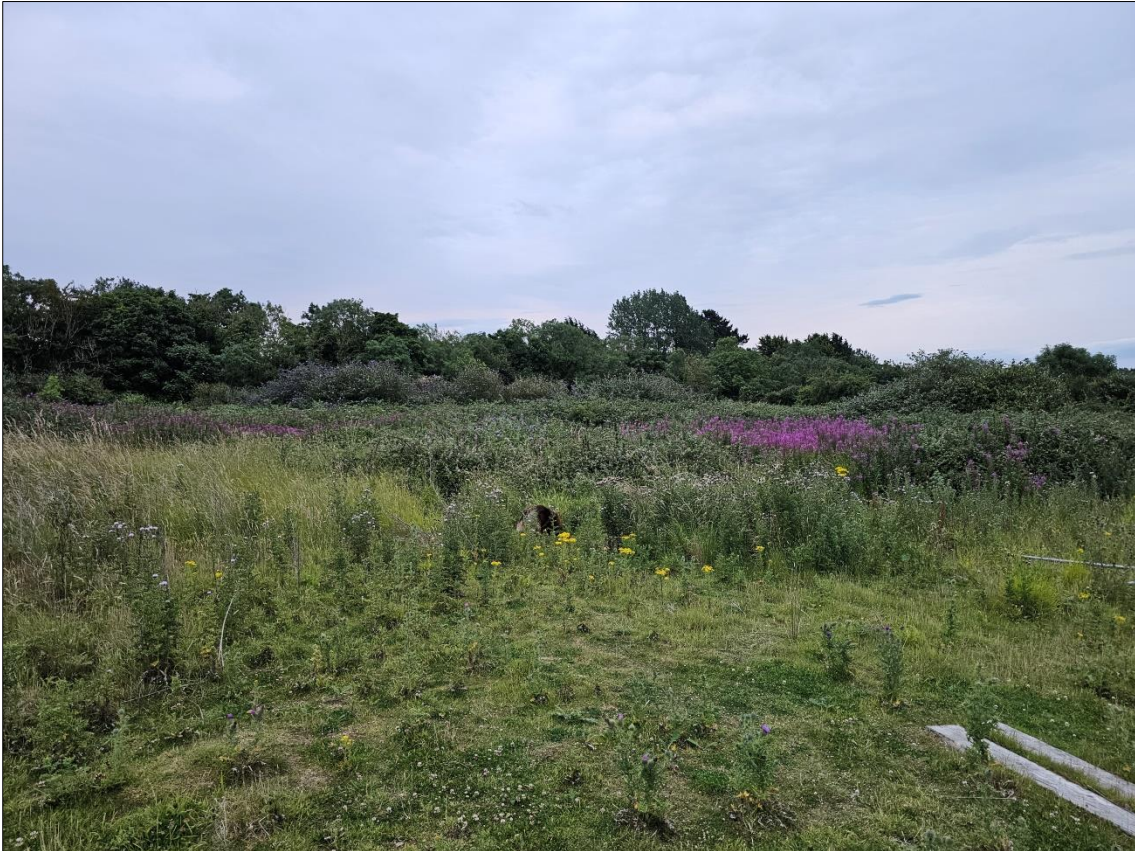
Plate 3. Scrub at the southern end of the rugby club lands.

The southern portion of the former Rugby Club lands are dominated by scrub (WS1) consisting of dense tangles of bramble (*Rubus fruticosus* agg.), the non-native invasive butterfly bush (*Buddleia davidii*), and scattered immature ash (*Fraxinus excelsior*). This area is described as G226 in the tree survey report and is well used by Rabbits. Colonising species such as thistles (*Cirsium arvense*) and rosebay willowherb (*Epilobium angustifolium*) are common here as is the invasive non-native species Canadian fleabane (*Conyza canadensis*).

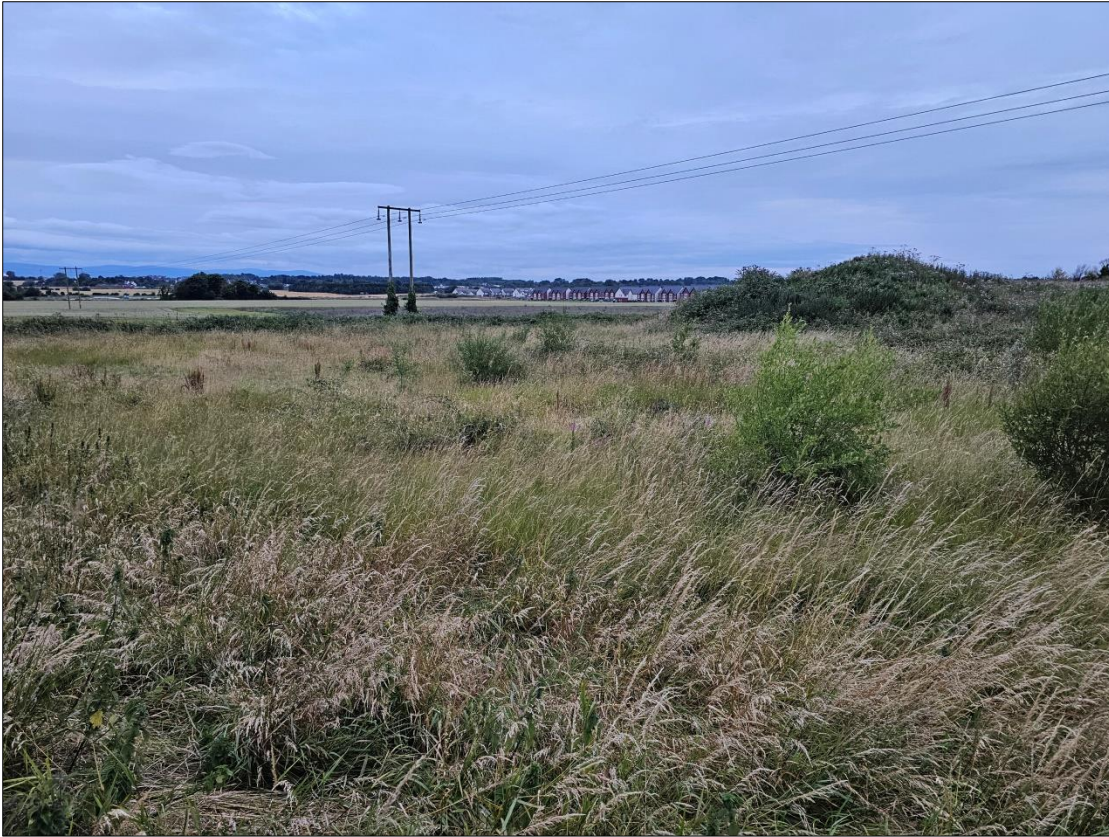
Plate 4. Looking south west over the drainage ditch and adjoining agricultural lands from the southern end of the site towards Brookfield.

Along the drainage ditch at the southern boundary of the lands are Sycamore, Hawthorn and Bramble (described as G225 in the tree survey report).

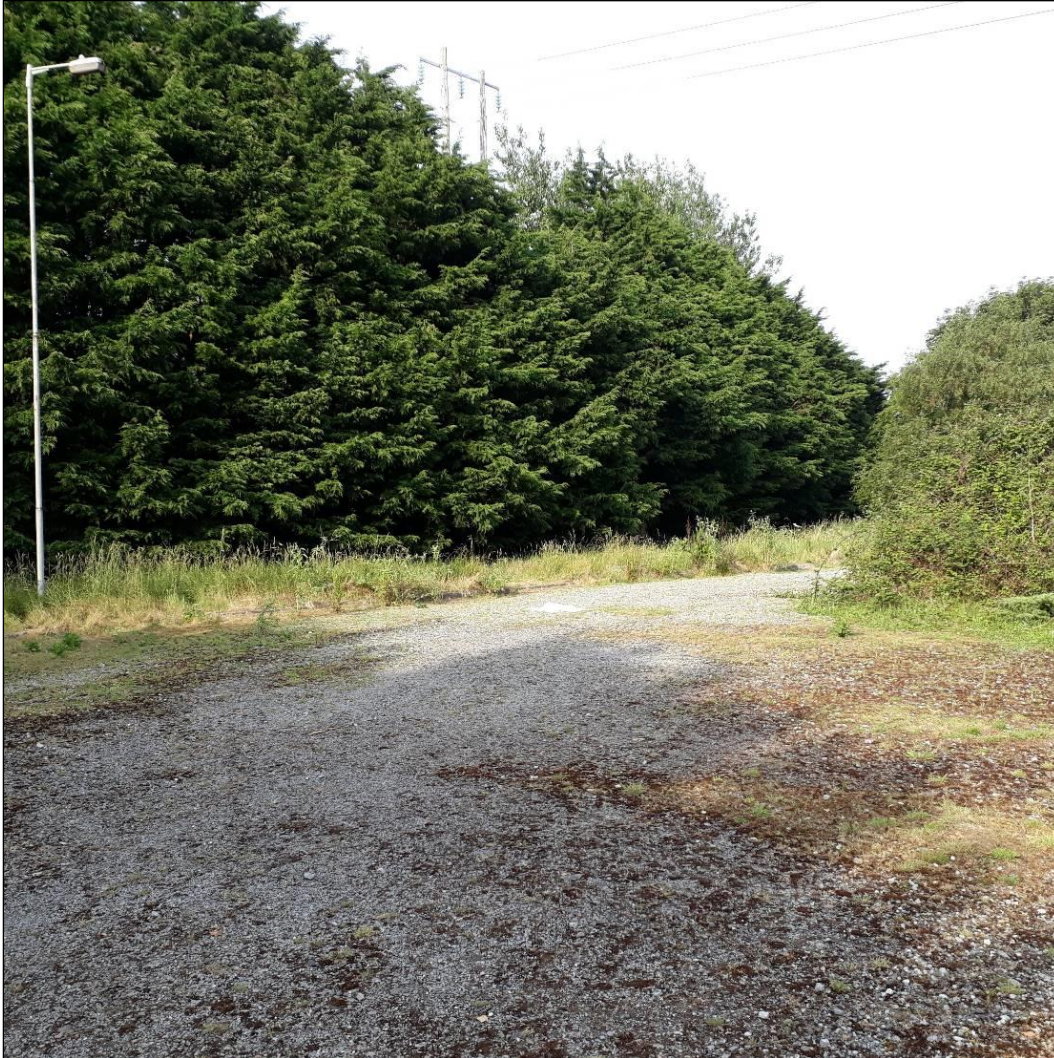
Plate 6. Treeline to the north of the rugby club.

The treeline (WL2) extending to the west of the rugby club building has cherry laurel (*Prunus laurocerasus*), silver birch (*Betula pendula*) and false cypress (*Chamaecyparis* sp.) with frequent bramble. This area is described as G186 in the tree survey report. Dense bramble tangles and several ornamental shrubs are also found around the building forming an area of scrub (WS1).

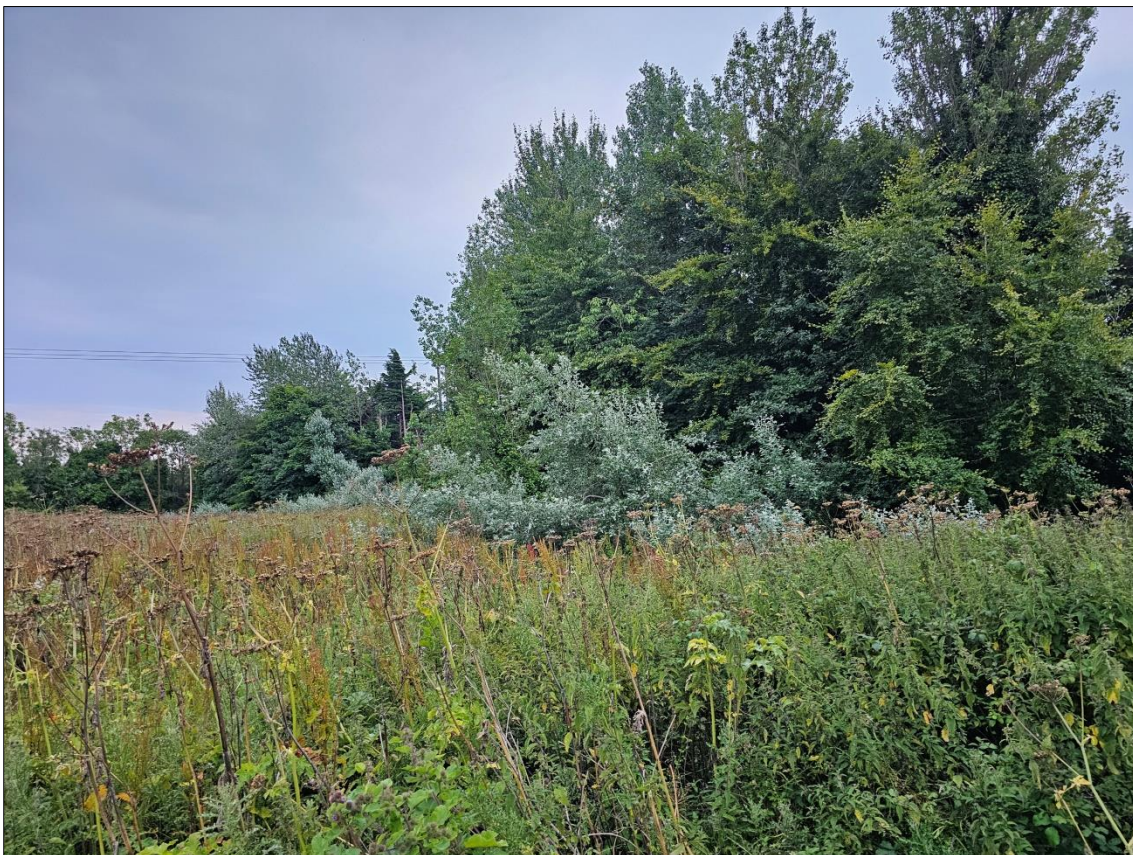
Plate 7. The trees between the rugby club and the northern field.

A double treeline (WL2) of Leyland cypress (*Cupressocyparis x leylandii*) (G198) separates the rugby club building from a small field to the north. A deep drainage ditch (FW4) which was dry at the time of survey is found at the base of this treeline and an old disused badger (*Meles meles*) sett, which is currently used by fox (*Vulpes vulpes*) is located here. Three rows of mixed plantings of whitebeam (*Sorbus aria*), apple (*Malus* sp.), cherry (*Prunus* sp.), sycamore, beech (*Fagus sylvatica*), hawthorn (*Crataegus monogyna*), Lombardy poplar (*Populus nigra 'italica'*) and white poplar (*Populus alba*) are found on the north side of this treeline forming an area of immature woodland (WS2) described as G200, G201 and G202 in the tree survey report. Elder, bramble and hawthorn are also present.

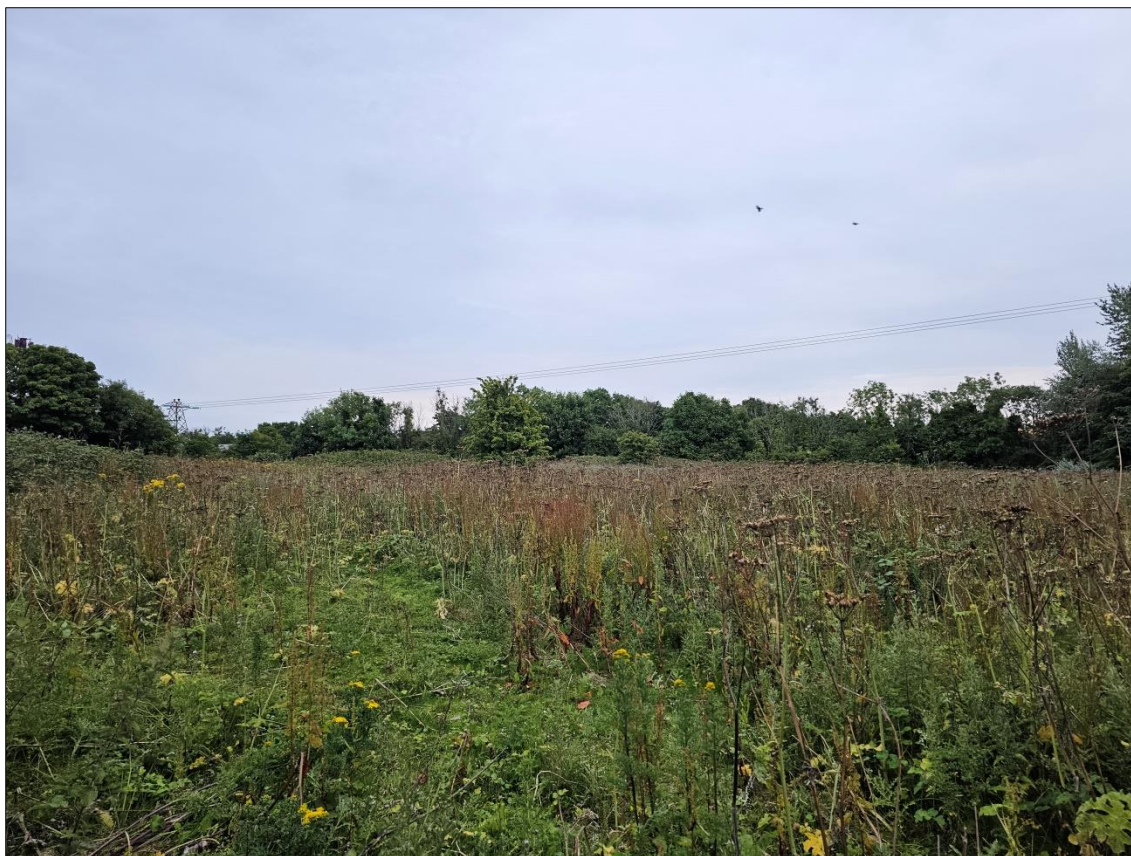
Plate 8. Northern field.

A deep ditch adjoins an earthen bank (BL2) on the eastern boundary and a double hedgerow (WL1) of hawthorn, ash, sycamore and bramble (G206 in the tree survey report) is found here. Numerous rabbit burrows are found on the earthen banks (BL2). An old laneway (possibly a way leave for the railway) is located between it and the fence of the railway line beyond which is a treeline (WL2) of ash, sycamore and hawthorn (G207 in the tree survey report). This is vegetated with hogweed, ivy (*Hedera helix*), bramble, bush vetch (*Vicia sepium*), nettle, false-brome (*Brachypodium sylvaticum*), sycamore seedlings, greater plantain (*Plantago major*), ragwort (*Senecio jacobaea*), docks, Yorkshire fog and lesser burdock (*Arctium minus*).

The northern boundary of the northern field is demarcated by a hedgerow (WL1) of ash, elder (*Sambucus nigra*), bramble and sycamore with occasional mature ash and sycamore (G211 and G213 in the tree survey report). An ESB substation is located here.

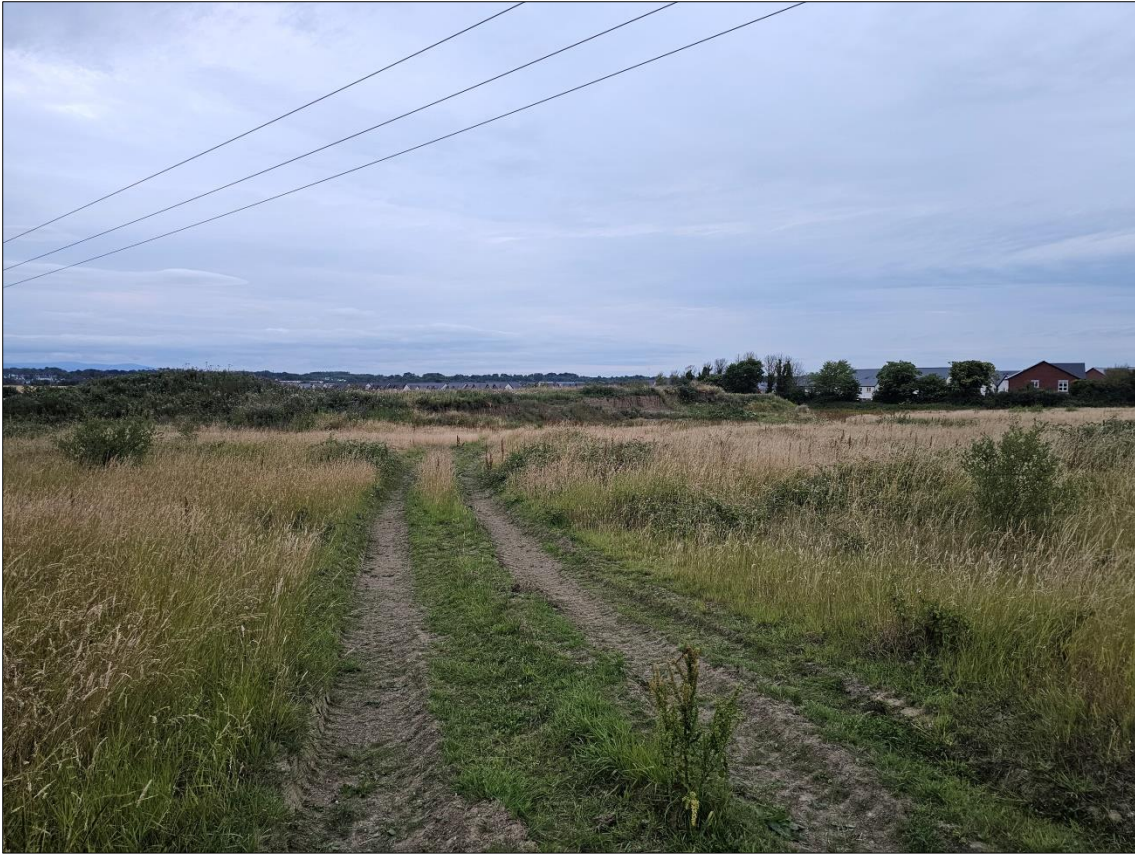
Plate 9. Looking south west over the western field to the areas of stored topsoil.

A large volume of topsoil was previously stored here from the Ashwood Hall development and this has been colonised with a variety of species including the non-native invasives Butterfly bush, Large bindweed (*Calystegia sylvatica*) and Canadian fleabane as well as bramble and thistles. A small depression at the base of the soil storage area now supports wetland plants such as reed mace (*Typha latifolia*) and hoary willowherb (*Epilobium hirsutum*). Within the grassland areas curled dock (*Rumex crispus*), white clover, creeping buttercup (*Ranunculus repens*), ribwort plantain (*Plantago lanceolata*), creeping cinquefoil (*Potentilla reptans*), weld (*Reseda luteola*), broad leaved plantain, hoary willowherb, broad-leaved willowherb (*Epilobium montanum*), ragwort (*Senecio jacobaea*), knotgrass (*Polygonum aviculare*), and wild radish (*Brassica rapa*) were frequently recorded as were willows and young oak saplings which have developed through natural succession.

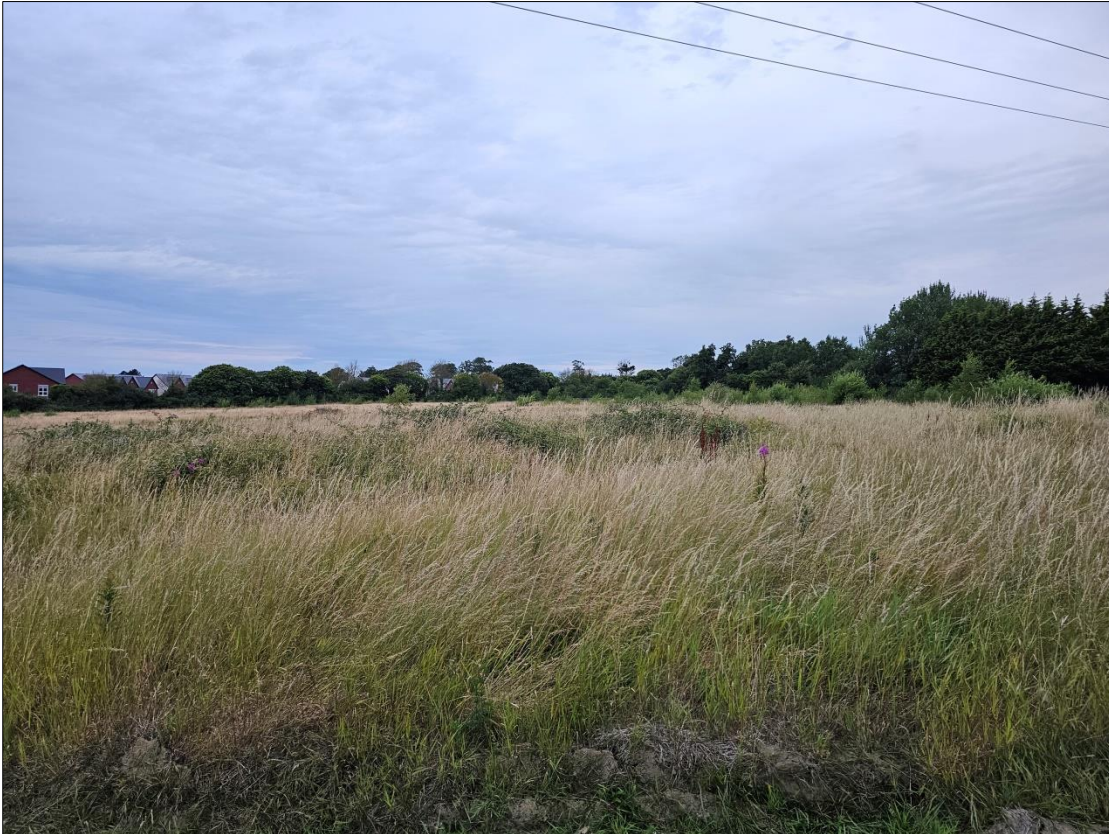
Plate 10. Looking north west over the western field to the shared treeline boundary with Ashwood Hall and the southern boundary of the former residences.

This field is bounded to the west by the shared treeline (WL2) of Ashwood Hall (described as G6, G243, G244, and G245 in the tree survey) which is dominated by mature and semi-mature ash (*Fraxinus excelsior*), oak (*Quercus robur*), wild cherry (*Prunus avium*), sweet chestnut (*Castanea sativa*), sycamore (*Acer pseudoplatanus*), and beech (*Fagus sylvatica*) with an understorey of hawthorn (*Crataegus monogyna*), blackthorn (*Prunus spinosa*), Wych elm (*Ulmus glabra*), bramble (*Rubus fruticosus* agg.), elder (*Sambucus nigra*) and dog rose (*Rosa canina*). This treeline is located on a shallow earthen bank (BL2) with an associated deep drainage ditch (FW4) which was dry at the time of survey.

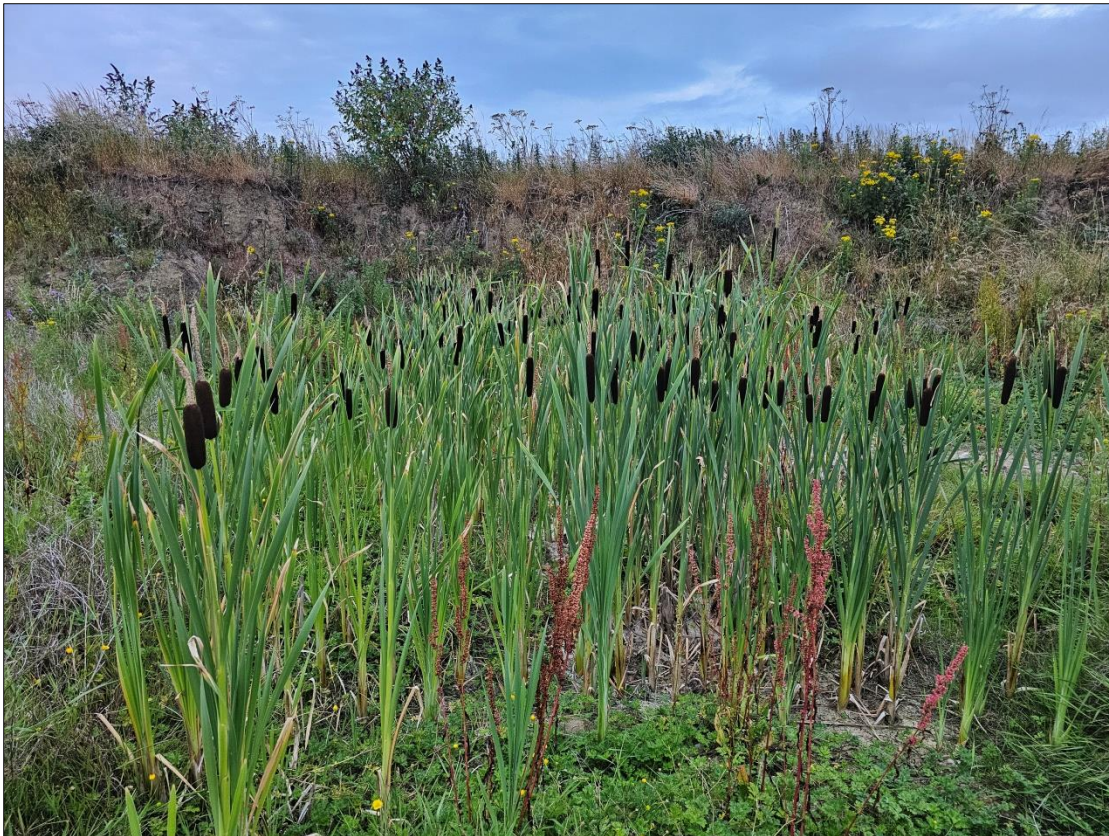
Plate 11. A small wetland has formed at the base of the soil storage area.

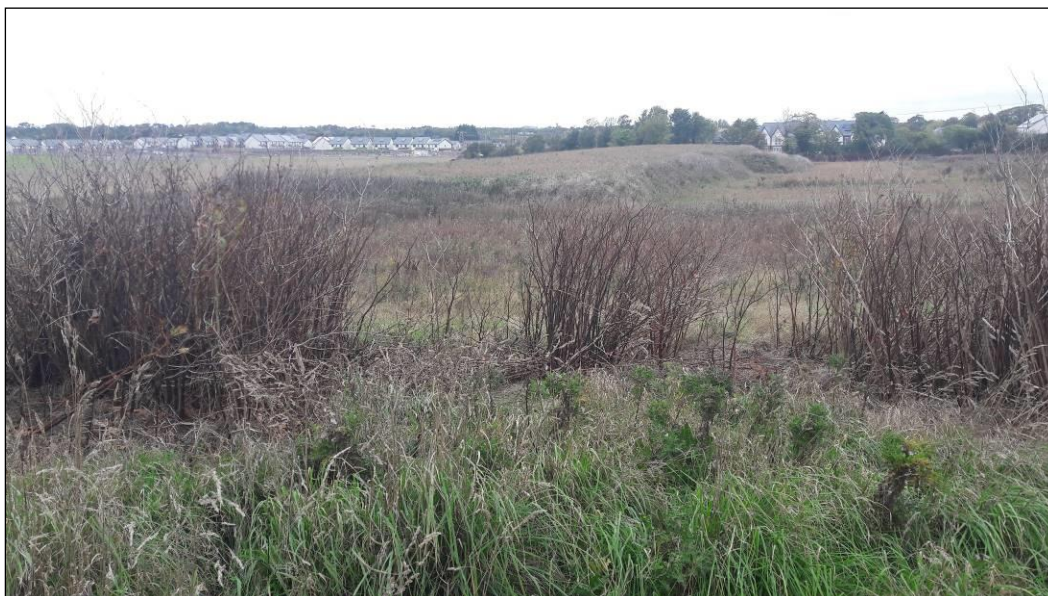
Plate 12. Japanese knotweed on the former rugby club lands following treatment in 2018.

Birchwell Developments engaged a trained horticulturalist (Graeme Cahill) to begin treating the Japanese knotweed in 2017. The first treatment of the knotweed at Broomfield was on May 19th 2018. An application rate of 100ml Glyphosate:5 litres water was used. A total of 3 litres of spray was applied via a knapsack sprayer. Follow up treatment has since been conducted over many years. A detailed Japanese knotweed management plan was developed to ensure that this species is not and has not inadvertently been spread during development of the site.

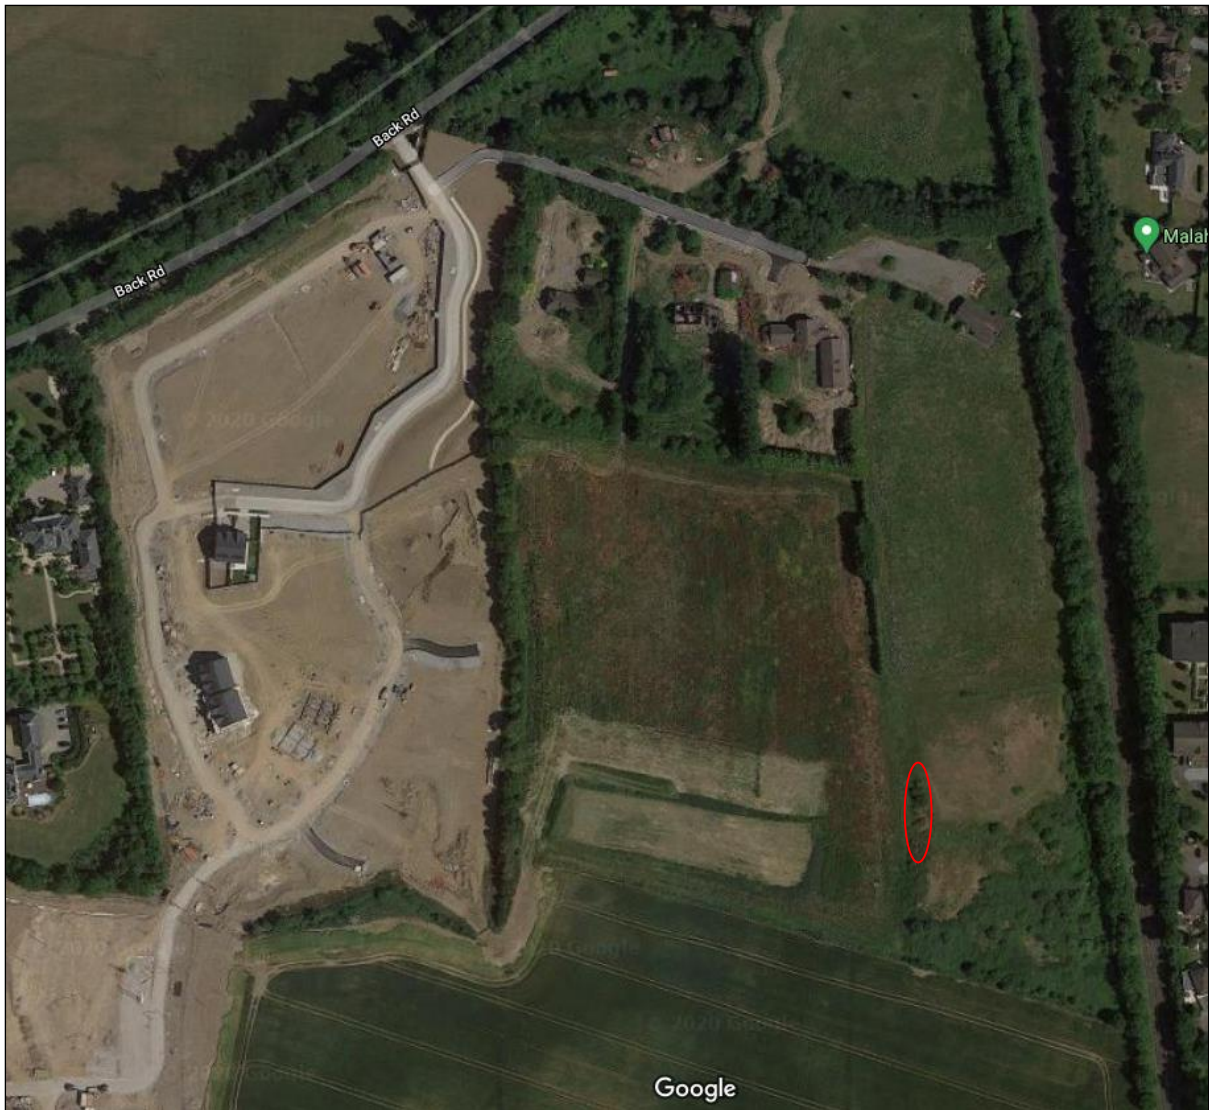
Figure 5.5. Japanese knotweed was recorded here in 2017 and has been treated on site since then by Birchwell.

The main invasive species noted in the general vicinity include stands of Japanese knotweed (*Fallopia japonica*), Canadian fleabane and butterfly bush (*Buddleia davidii*) which were found within the rugby club lands. Of these the Japanese knotweed is the only species listed under the Third Schedule of the Communities Birds and Natural Habitats Regulations 2011. The location of the Japanese knotweed stand is shown on **Figure 5.5** below.

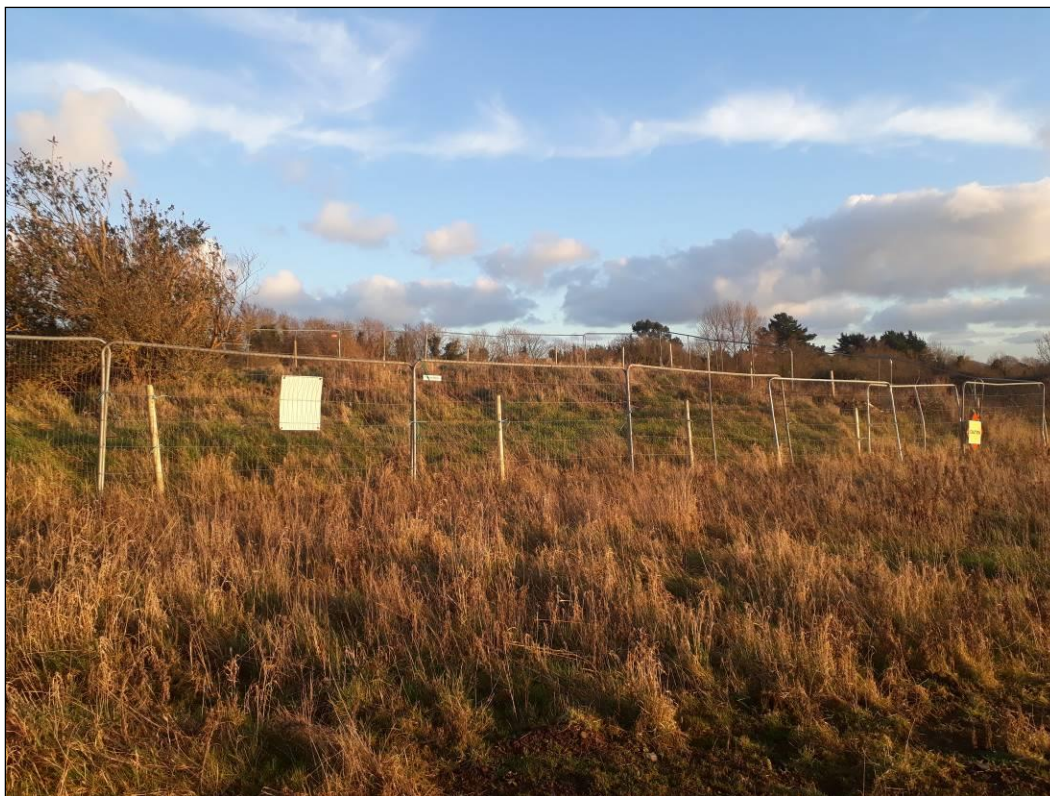
Plate 13. Japanese knotweed areas clearly demarcated and treated in January 2021.

The Japanese knotweed has been the subject of ongoing treatment in situ and has not spread or become established elsewhere within the site in the intervening period.

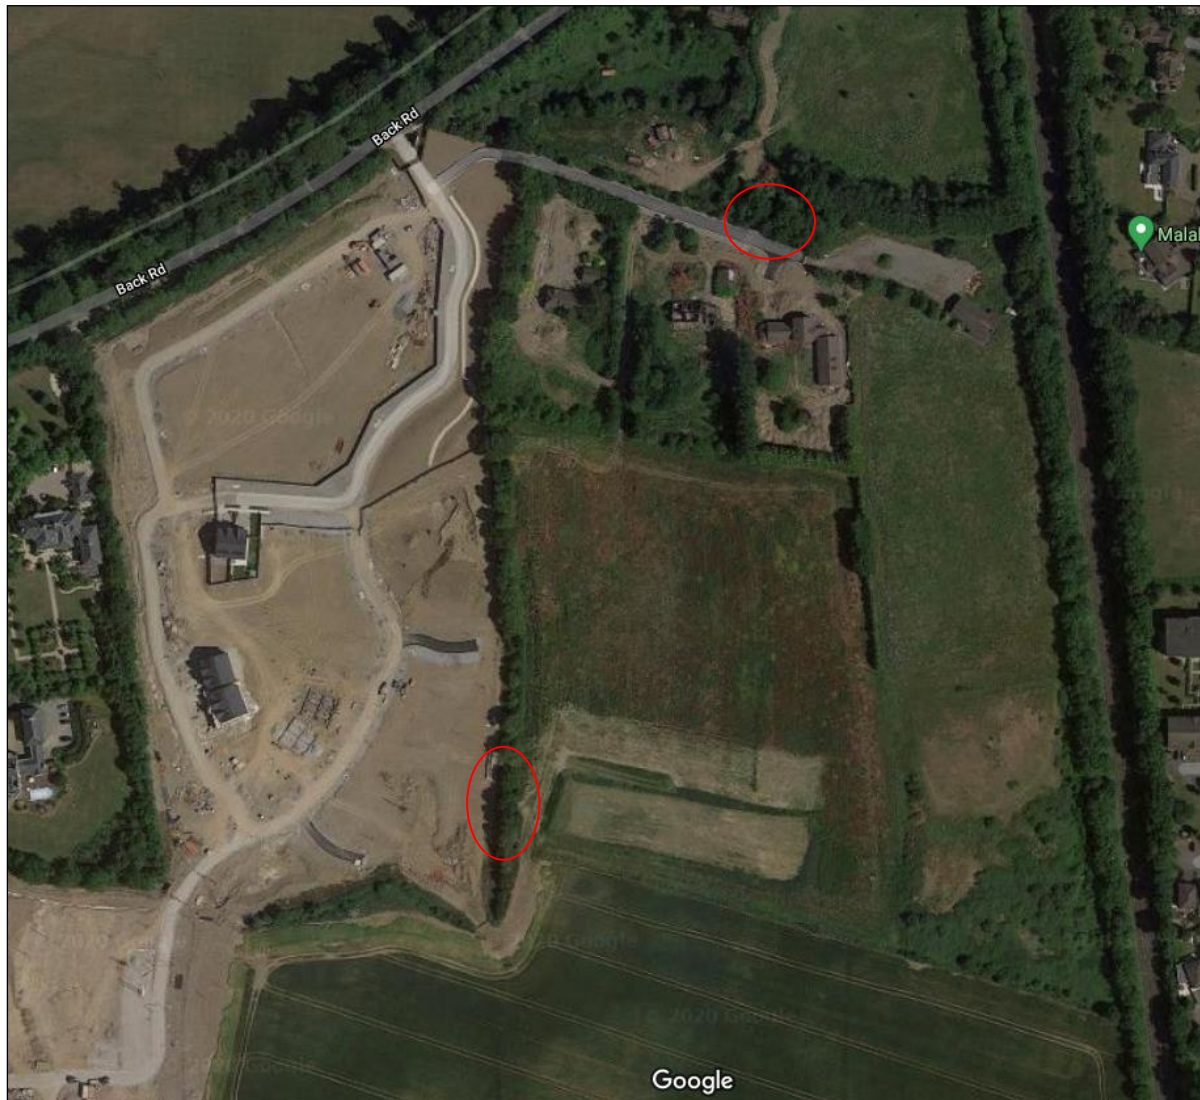
Figure 5.6. Potential badger setts within the Broomfield LRD lands.

This potential badger sett consisted of a single entrance sett, which was not active at the time of the initial or subsequent surveys. This and a number of other holes and burrows in the area are well used by rabbits but there has been no evidence of any subsequent or current use by badger in further surveys conducted since 2014. At the initial time of identification in 2014 there were feeding signs of badger noted along the southern boundary of the Broomfield Phase 1 lands and a dead badger was noted on the Back Road to the west of the entrance to Malahide Castle which triggered the suggestion that this sett was potentially used by badger.

Broomfield LRD lands were used by badgers as outlier setts to a main territory, which is located within Malahide Castle Demesne.

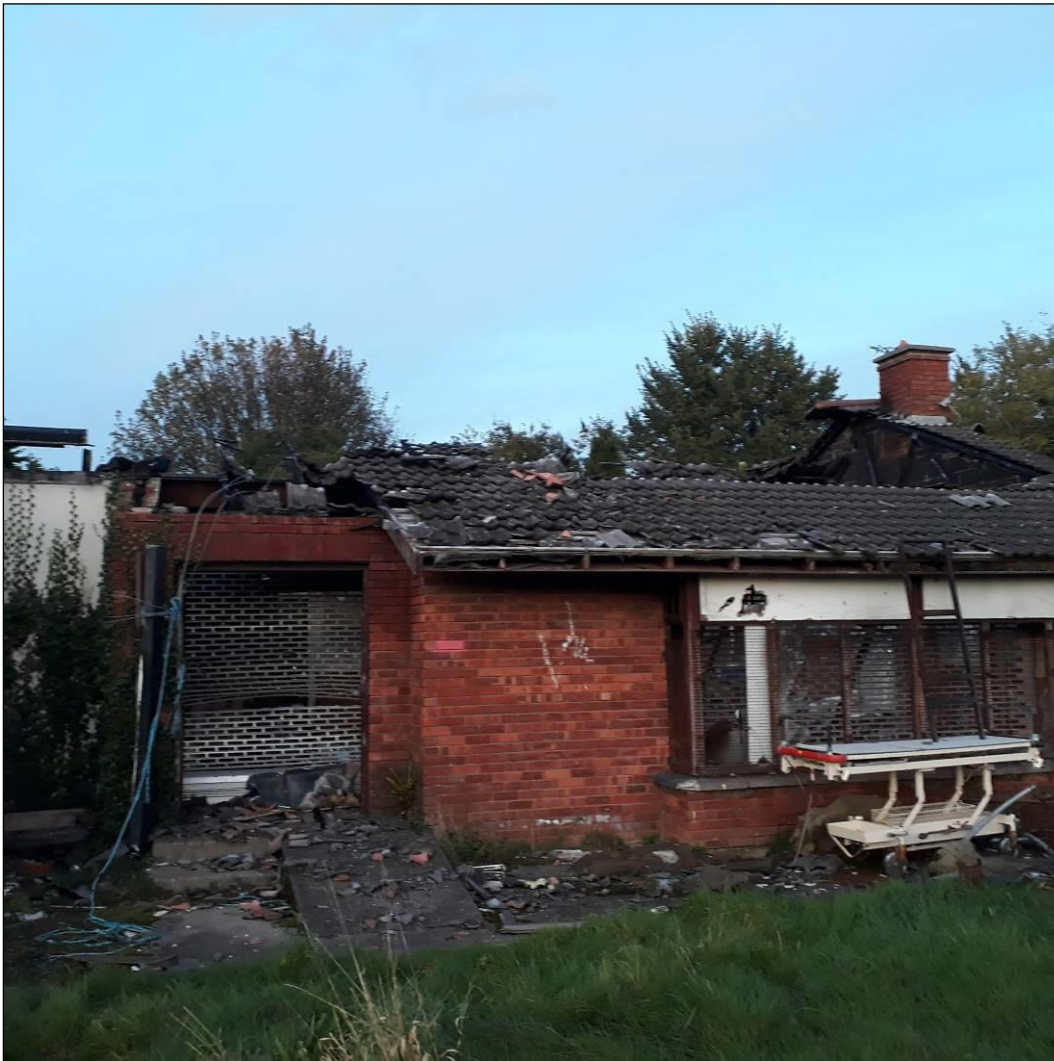
Plate 14. Rugby club building destroyed by arson in 2019.

Leisler's bat was recorded foraging over the lands and over the area of scrub south of the rugby club building. The rugby club building had been the subject of arson and no longer has an intact roof/attic space. No bats were recorded emerging from this property.

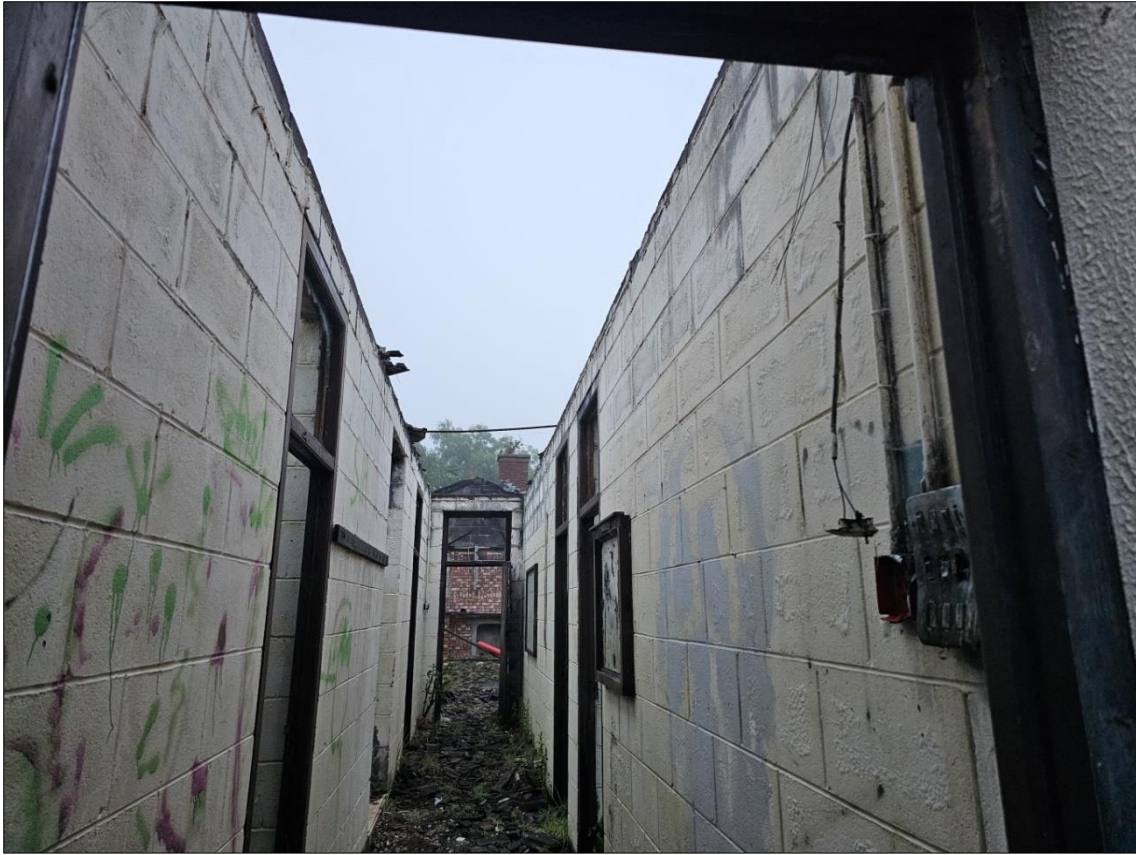
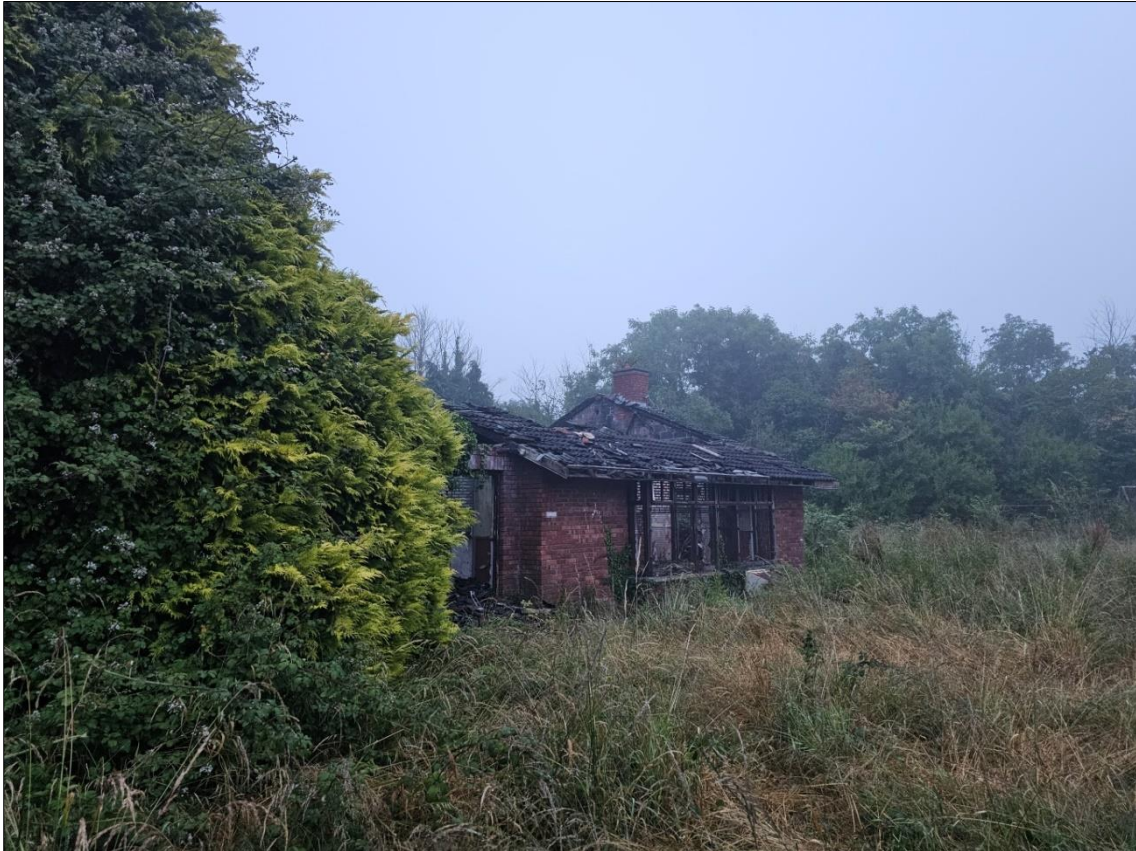
Plate 16. Former rugby club building in 2024.

Plate 17. Former rugby club building in 2024.

The bat survey conducted on the 9th July 2024 recorded similar activity to that in 2022. No bats were recorded emerging from the arson damaged rugby club building. The condition of this building has deteriorated further since it was last surveyed as can be seen on **Plate 16** below.
