5.0 BIODIVERSITY

Faith Wilson Ecological Consultant was commissioned by Birchwell Developments to prepare an Ecological Survey and Impact Assessment as part of a Large-scale Residential Development (LRD) Application for lands proposed for development on lands at Broomfield, Back Road, Malahide, Co. Dublin as shown on **Figure 5.1** below.

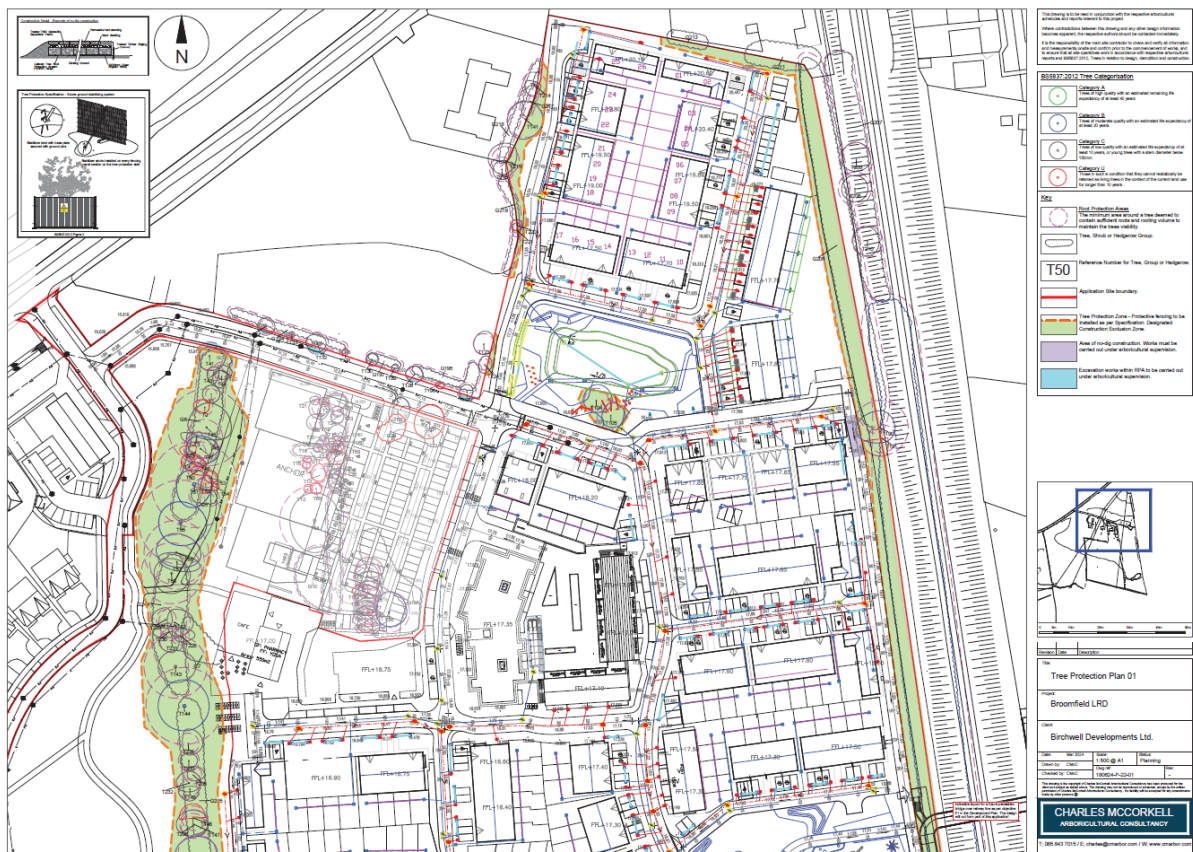
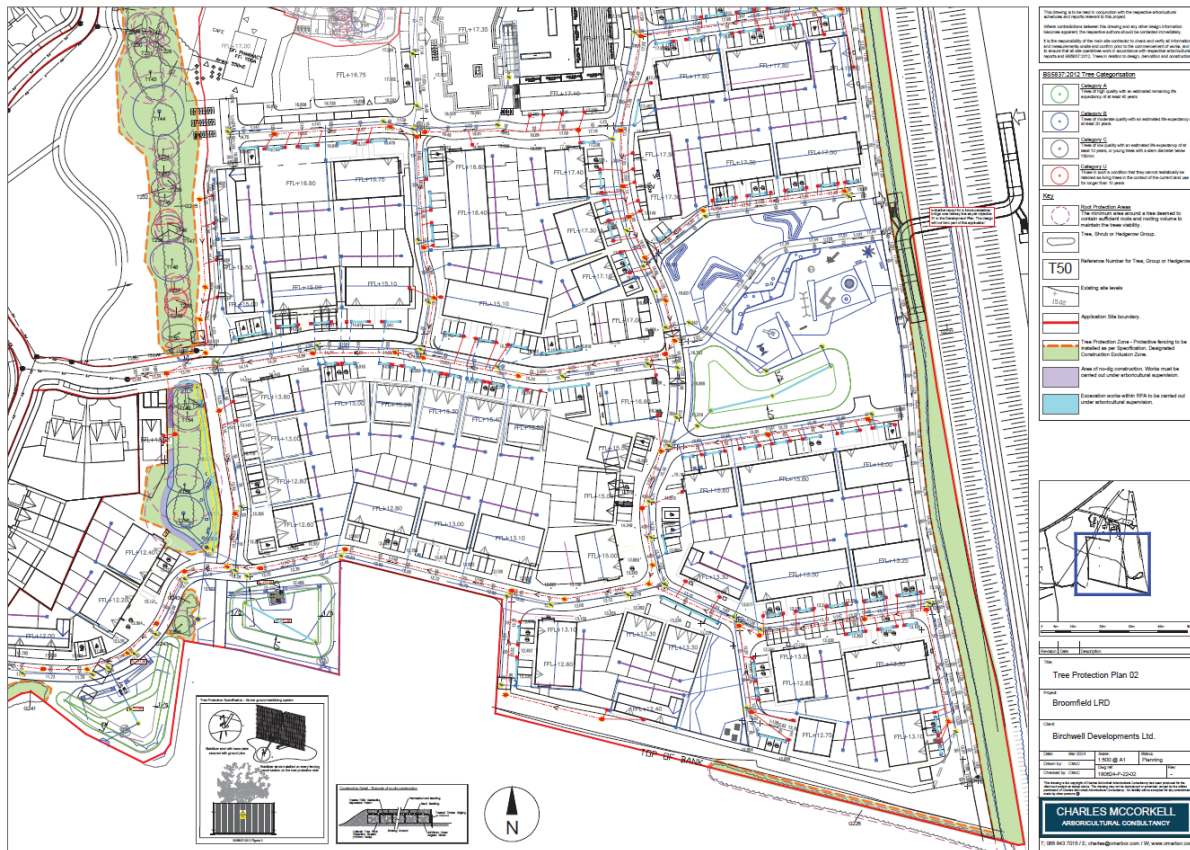
Figure 5.16. Tree Protection Drawing (Mc Corkell (2024)).

Figure 5.17. Tree protection Drawing (Mc Corkell (2024)).

These retained treelines, hedgerows, and associated drainage ditches will be given protection from accidental damage by machinery during site works prior to any works commencing in the development and as set out in the arboricultural impact statement. **These areas will be clearly delineated by fencing or other measures. Fences will be erected outside the drip-line or canopy of each tree in accordance with BS 5837 (2012) – Trees in Relation to Construction.** Please refer to the arboricultural tree protection drawings (Figures 5.16 and 5.17 below).

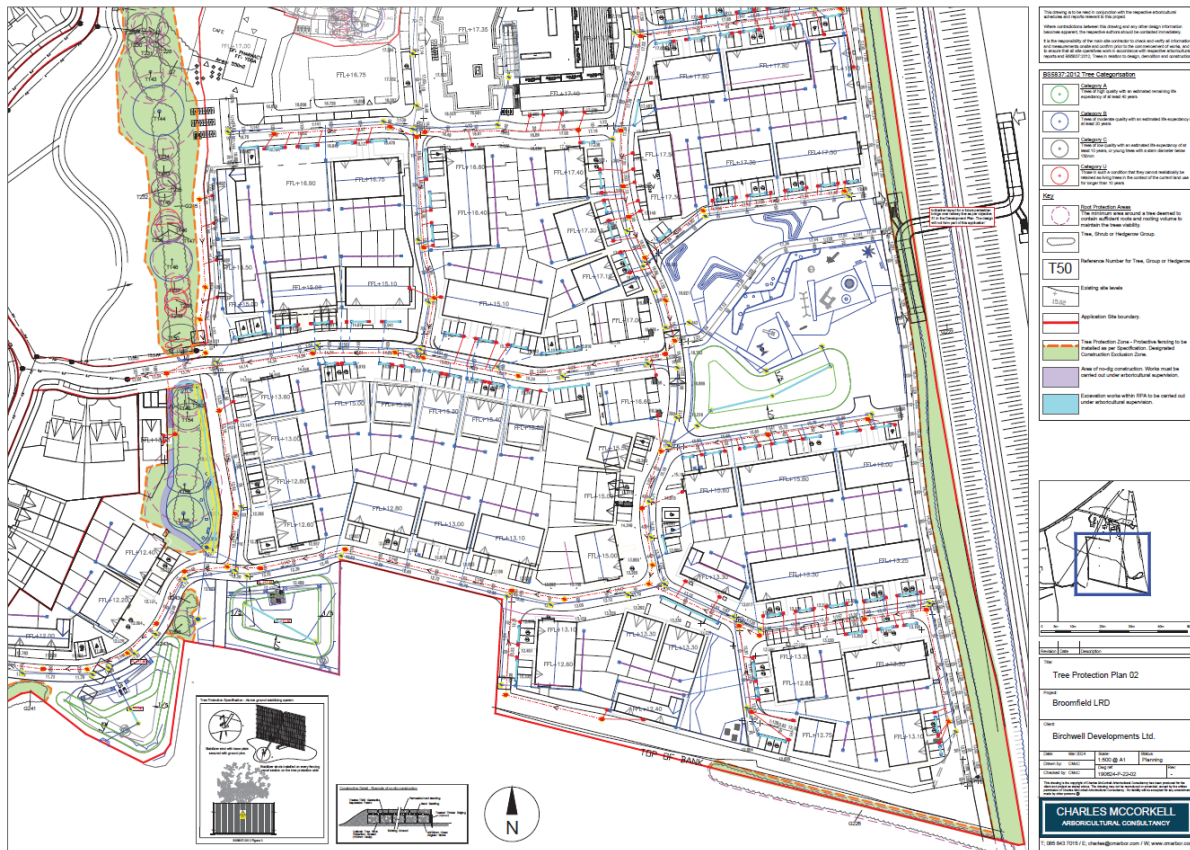
Figure 5.18. Badger protection zone – southern sett.

Both this treeline and inactive badger sett will be afforded protection as set out in the arborist's report and accompanying drawing (see **Figure 5.18** below) to ensure that the retained trees, vegetation and sett are not damaged by the construction works. Any fencing measures deployed must incorporate access for mammals at the base – this should be a gap no smaller than 300mm high by 225mm wide. This will be inspected and signed off by the ecological clerk of works.

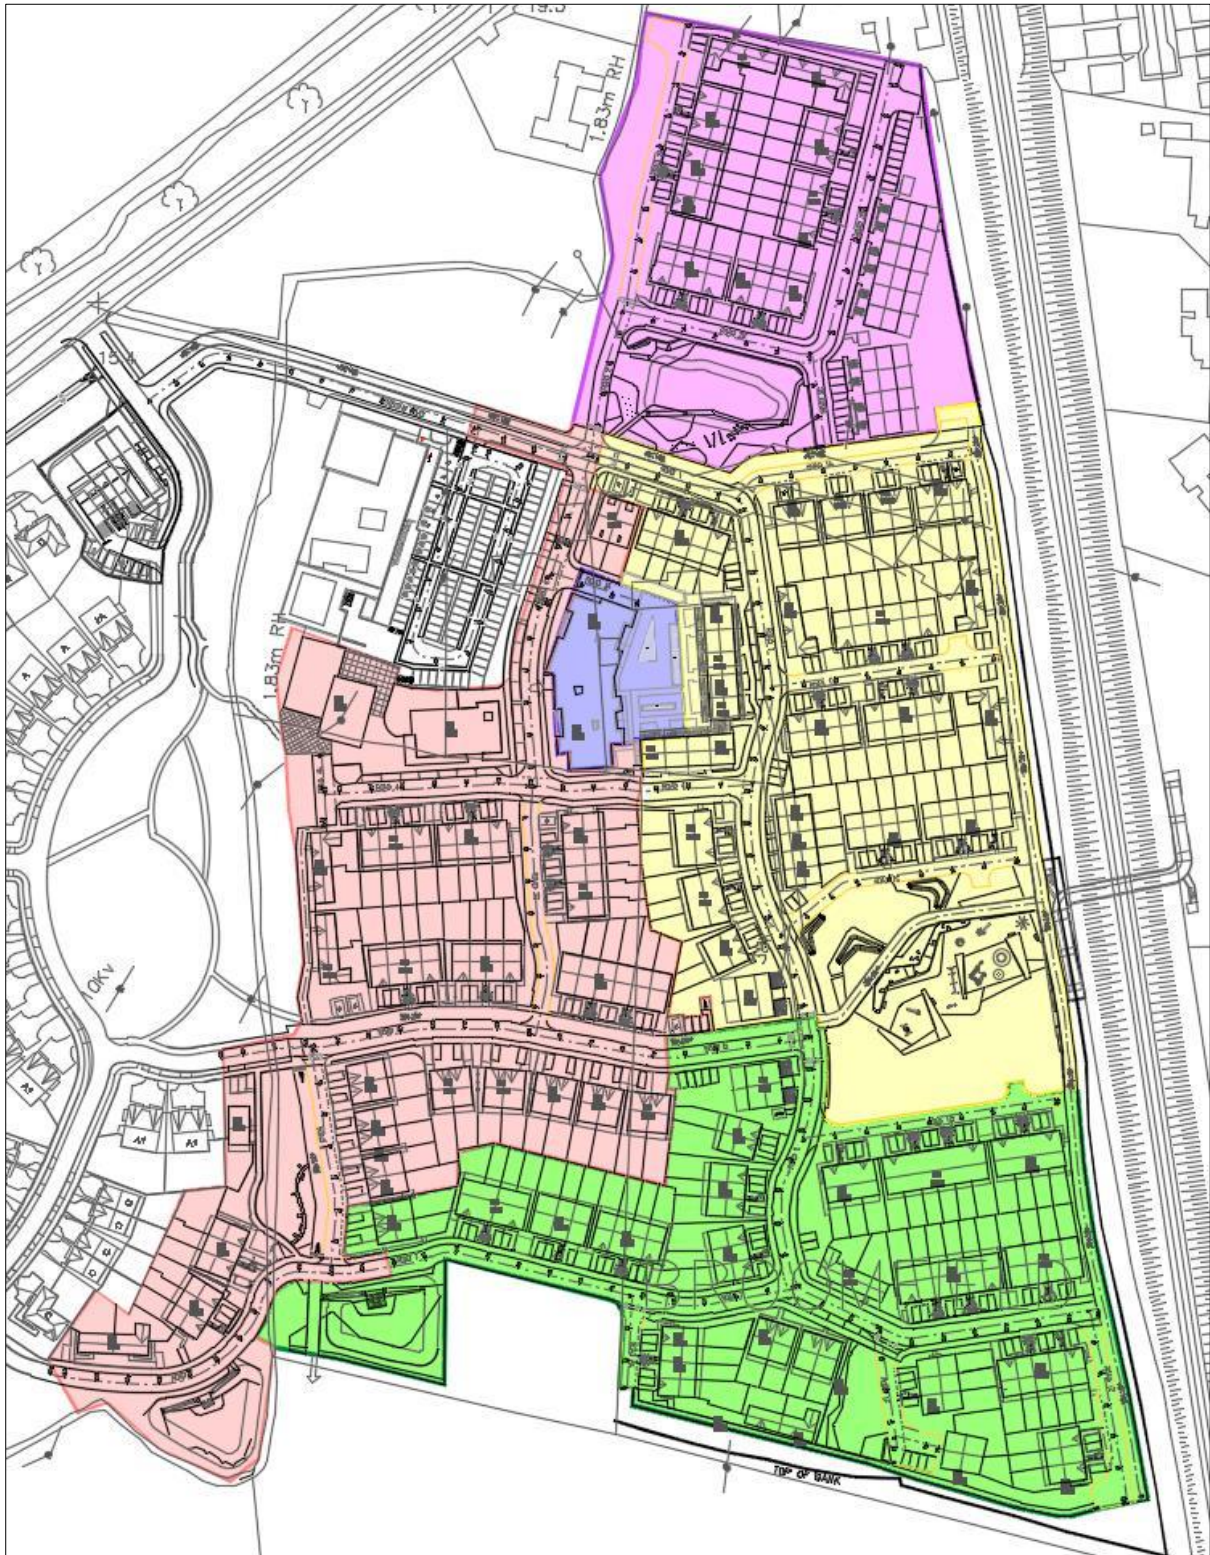
Figure 5.20 Indicative layout of the drainage network (Waterman Moylan, 2024).

Potential negative impacts could arise should untreated surface water enter the Hazelbrook Stream from the proposed development. These impacts have been addressed through careful consideration of the ground conditions within the site and the installation of silt traps and hydro-carbon traps as outlined in the Engineering Assessment Report and accompanying drawings prepared by Waterman Moylan Consulting Engineers, which will ensure that all surface water leaving the site is treated before it ultimately enters the Baldoyle Bay SAC/SPA.

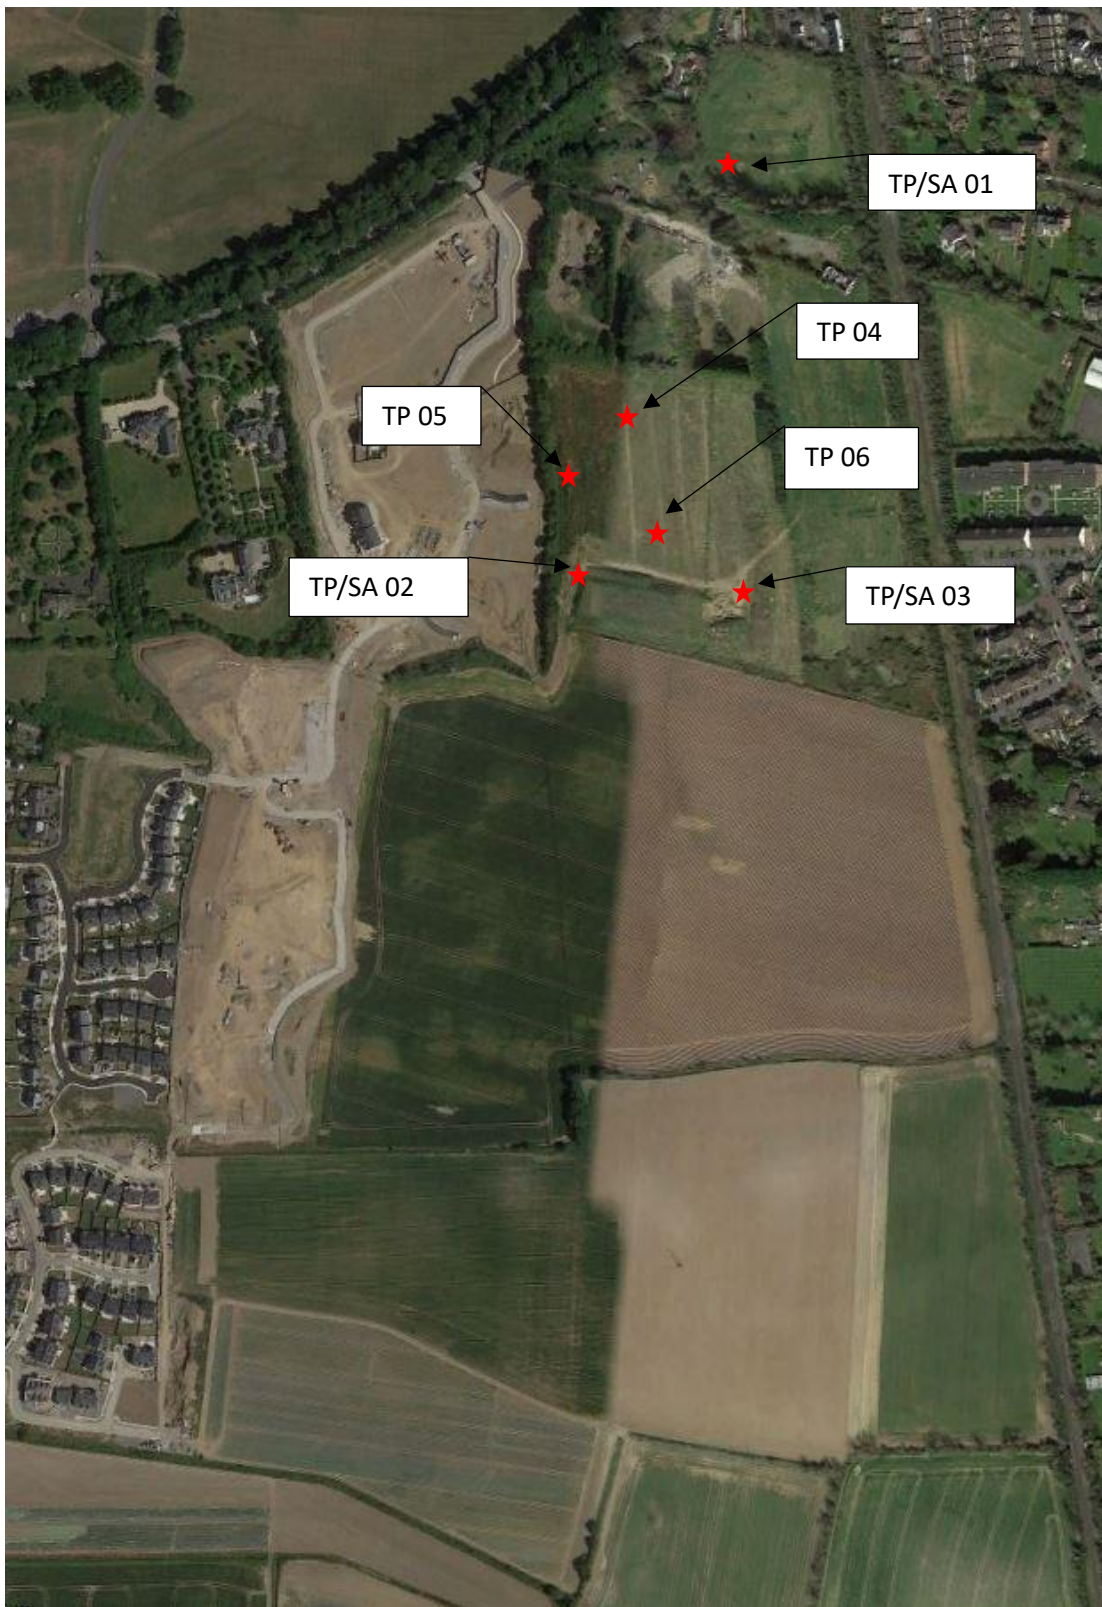
Figure 6.5 | Trial Pit (TP) & Soakaway (SA) Locations for the Subject Site Reports

Soakaway tests were also undertaken on 50% of the trial pits. The pit was filled with water and the level of groundwater recorded over time. As stipulated by BRE Special Digest 365, the pit should be filled 3 times and that the final cycle is used to provide the infiltration ratio. The time taken for the water level to fall from 75% volume to 25% volume is required to calculate the rate of infiltration. However, if the water level does not fall at a steady rate, then the test is deemed to have failed, and the area is unsuitable for stormwater percolation.

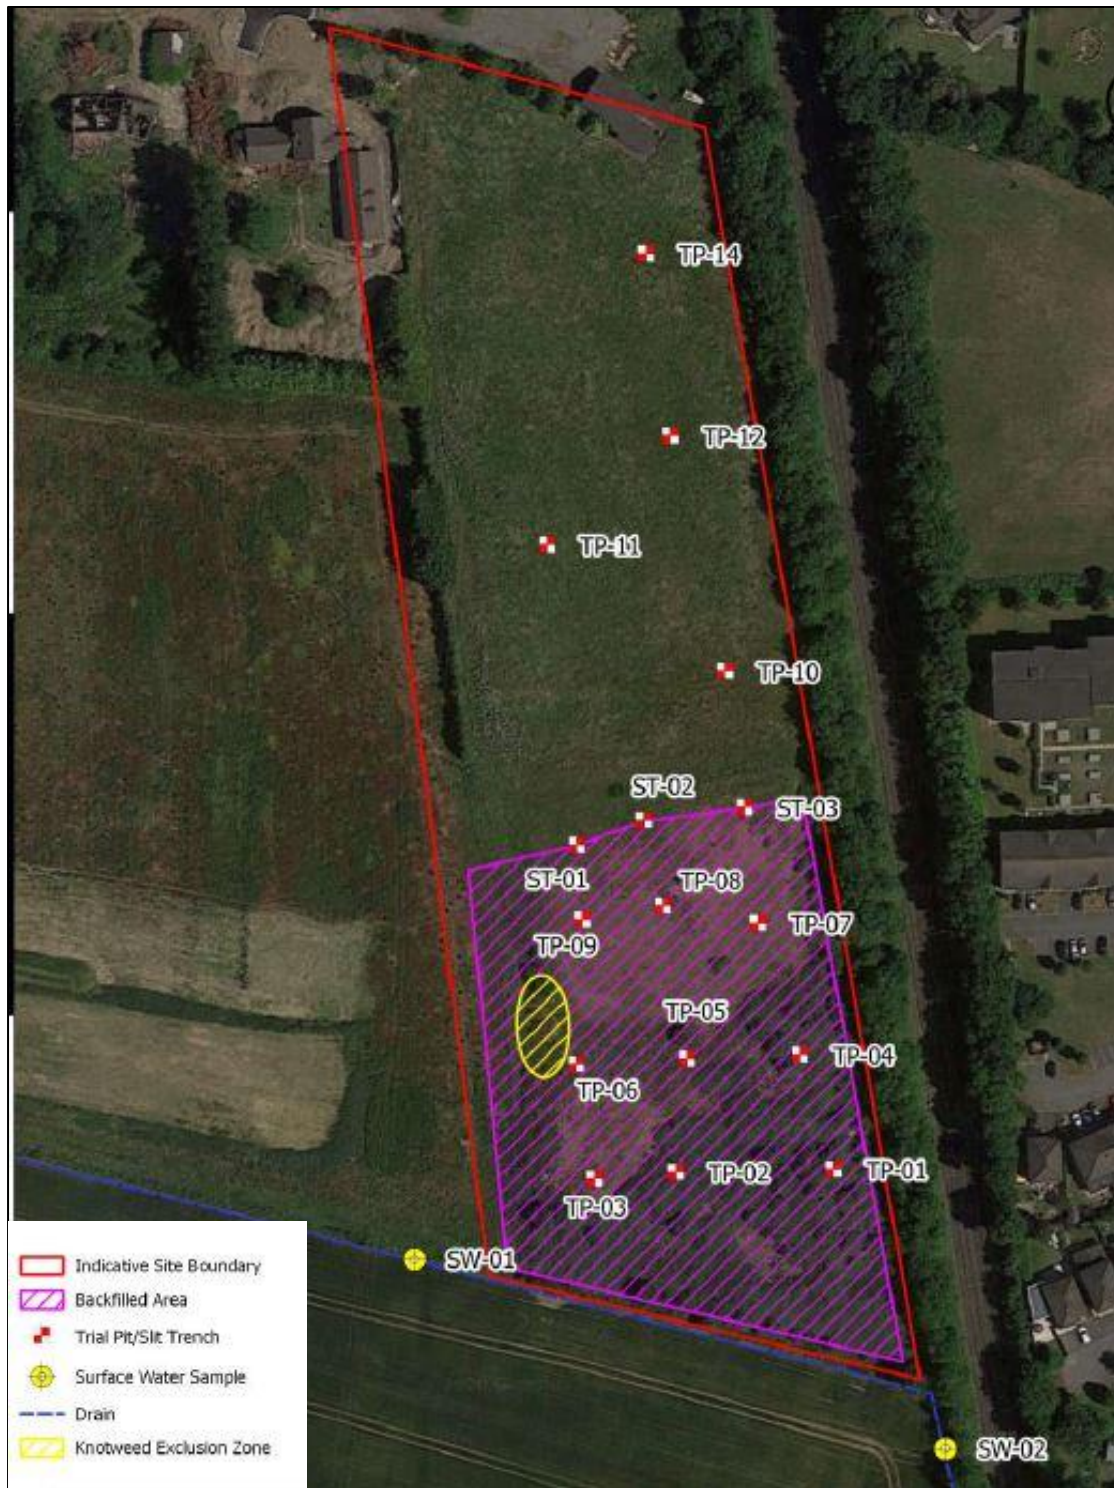
Figure 6.6 | Extract of Mapped Location from the GII Report

The image in Figure 6.6 overleaf, is extracted directly from the GII report and shows the location of the trial pits (TP), and slit trenches (ST), as well as indicating the area of the historic landfill with a purple hatch. Also noted with the yellow hatch is an area with Japanese Knotweed which when identified was immediately fenced off to prevent further accidental spread by inadvertent local excavations.

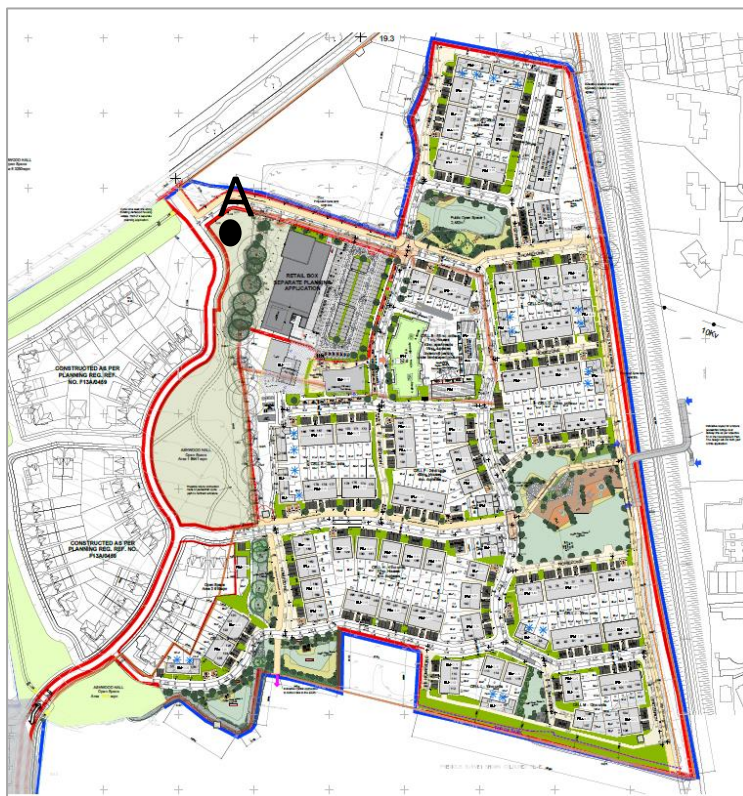
Image 8.3: Receptor location A.

Using the DMRB screening air dispersion model, pollutant concentrations in operational future years were predicted at the receptor location. In order to quantify the magnitude of change in pollutant concentrations, the descriptors in table 8.5. were used. To describe the significance of the impact, table 8.6 was then used. These descriptor tables are from the Transport Infrastructure Ireland Guidelines for the Treatment of Air Quality during the Planning and Construction of National Road Schemes which detail a methodology for determining air quality impact significance criteria for road schemes and has been adopted for this assessment. The degree of impact is determined based on both the absolute and relative impact of the proposed development. Results are compared against the 'Do-Nothing' scenario, which assumes that the proposed development is not in place in future years, in order to determine the degree of impact.

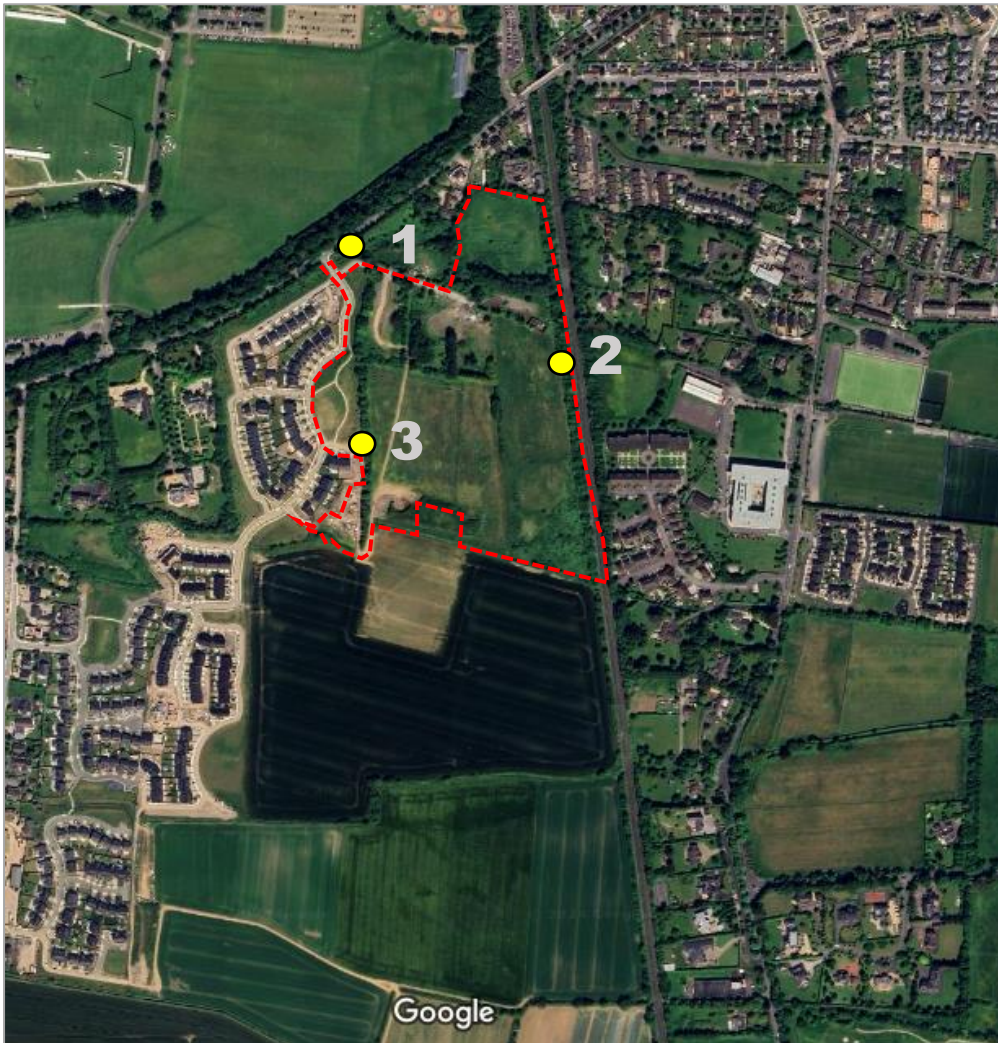
Image 9.1.1: receptor locations highlighted in yellow.

The table below represents the background noise monitoring locations chosen and image 9.1 highlights these monitoring stations on a site map.

Measurement location	Location	Measurement Type	Justification
Station 1	Back Road	Unmanned	To determine back ground noise levels
Station 2	Railway line	Unmanned	To determine back ground noise levels
Station 3	Site (nearest receptor)	Unmanned	To determine back ground noise levels
